**Air-Conditioning, Heating and  
Refrigeration Technology Institute**

AHRTI Report No. 9007-01

BENCHMARKING RISK BY WHOLE ROOM SCALE LEAKS AND IGNITIONS TESTING OF A2L REFRIGERANTS

UL LLC

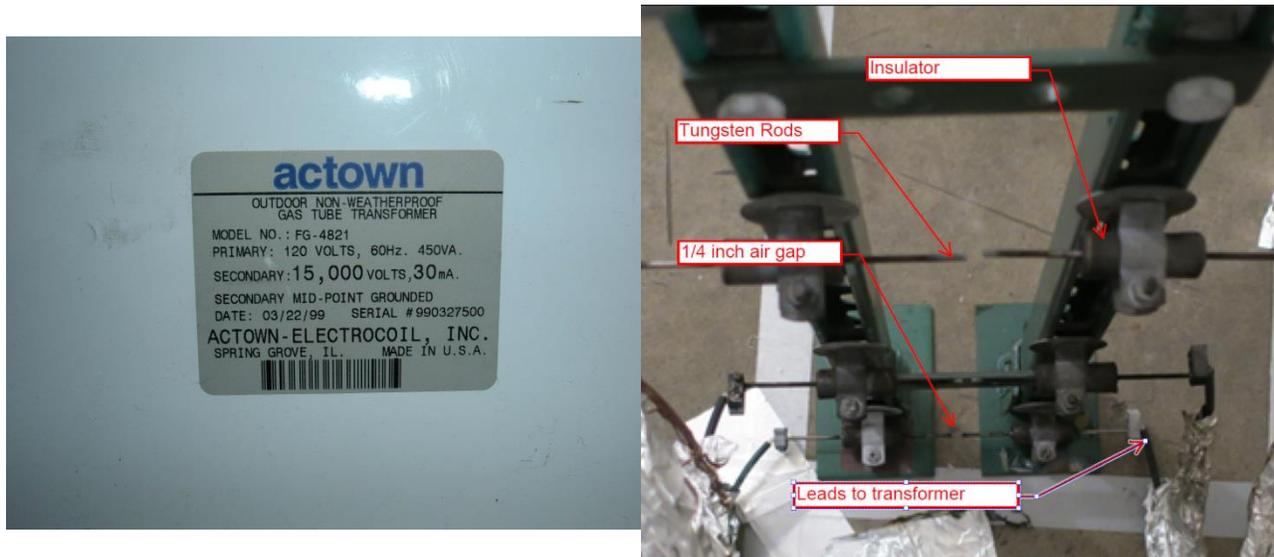
Figure 14 – Gas tube transformer and arc gap

A step-up gas tube transformer was used to create an electric arc as an ignition source. The leads of the transformer were connected to a pair of tungsten rods mounted such as to leave a ¼ inch air gap. Photographs of this equipment are included in Figure 14. Note that the transformer secondary ratings are based on open-circuit voltage and short-circuit amperage.

Table 6 shows the measured rms voltage and amperage developed by each electric arc/transformer pair. The rms power of the electric arc was 17.6 watts (joules/sec). The energy of the electric arc in one-half 60 Hz cycle (8,333  $\mu$ s) was 0.147 joules (147 mJ). This energy per half cycle cannot be directly compared to Minimum Ignition Energy (MIE) tests which use a single capacitive discharge with a much shorter duration (0.01 to 0.1  $\mu$ s).

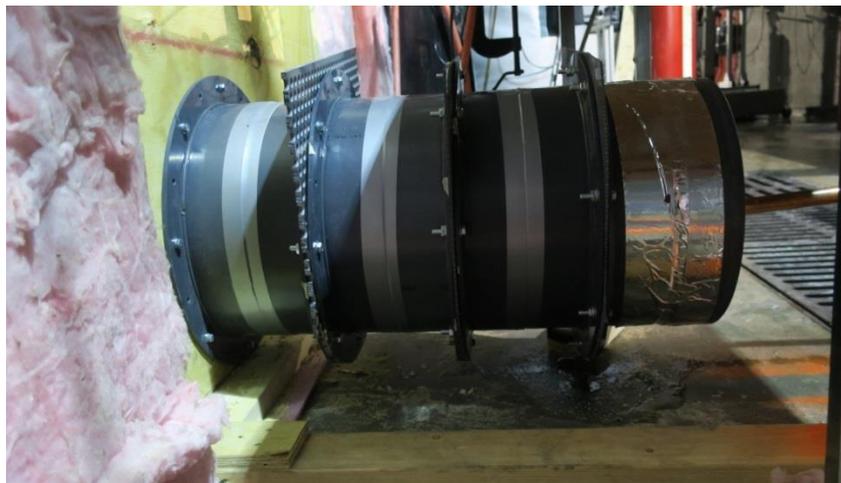
**Figure 19 – Photograph of the 14 in. Duct Assembly**

The 25 mm diameter release was achieved using a 25 mm ID copper tube. The 356 mm diameter release was achieved using 14 in. diameter PVC duct sections assembled with three diffuser plates to mix the refrigerant before releasing it into the test room. Each diffuser plate was 0.125 in (3.2 mm) thick and had different holes and total open area. The duct assembly is depicted in Figure 18.

A photograph of the 14 in. duct assembly connected to the test room is shown in Figure 19.

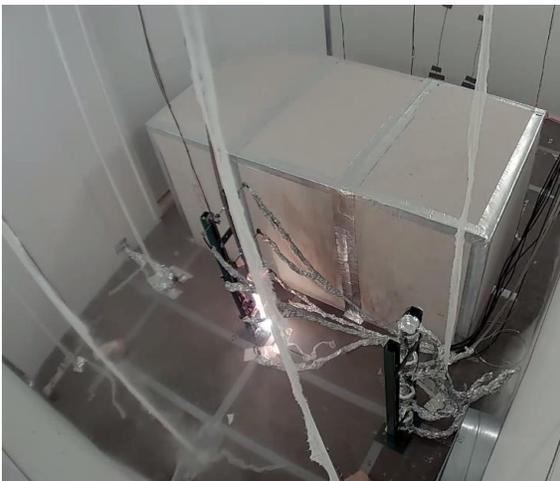
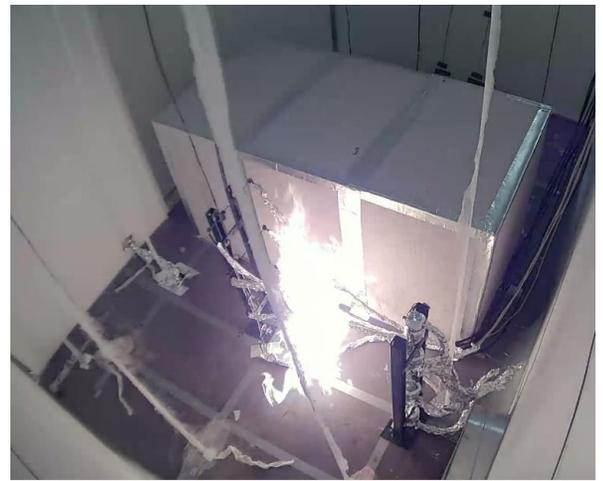
Figure 41 – Data from Cal05

There was ignition immediately after electric arcs were initiated. The fire event lasted approximately 30s. Selected data from the test are shown in Figure 41.

Electric arcs after release: 4:02

15s after Electric arcs

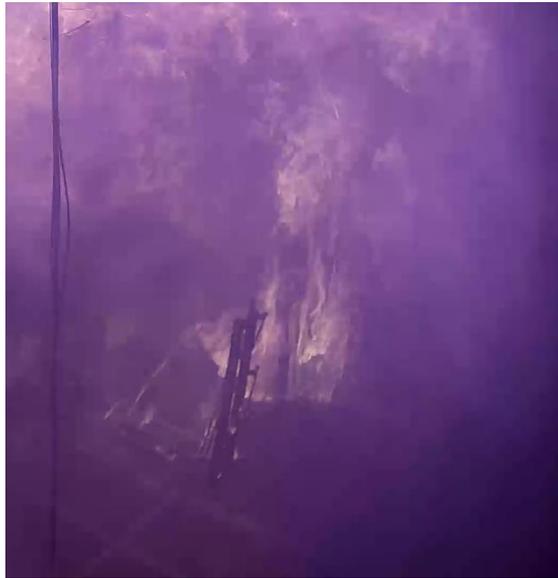
**Figure 57 – Flaming in test PB04 with two-thirds of planned flow rate**

Note that test PB04 was an R-32 refrigerant release with no obstruction in the room. There was an ignition. Since the release rate was only two-thirds of the intended release rate, it was not used for the graphs shown above. There was ignition and flaming (Figure 57) continued for 25 seconds after ignition.

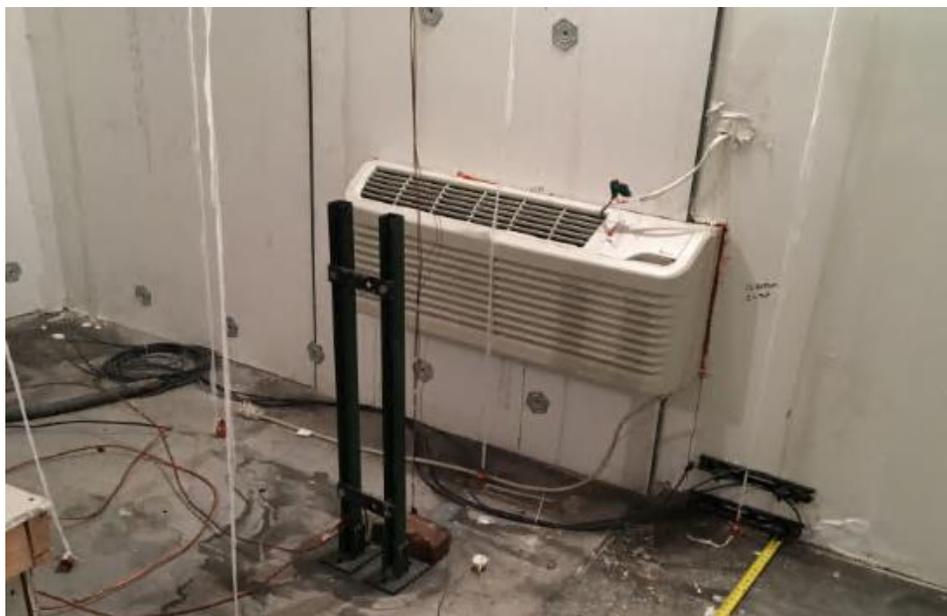
Figure 89 - Camera view of PTAC mounted in the center of the wall

The PTAC unit had dimensions of 48 x 16 inches (width and height) (1.2m x 0.4 m). The unit was mounted with a wall sleeve that was flush with the finished interior wall surface.

The motel room scenario involved the use of a Package Terminal Air Conditioner (PTAC) in a motel room layout. The test setup for the motel room is shown in Figure 86, Figure 87, Figure 88, Figure 89, and Figure 90. The motel room dimensions were 13 x 16 x 8-ft. (4.0 x 4.9 x 2.4m) high. An object representing a bed was located in the test area.

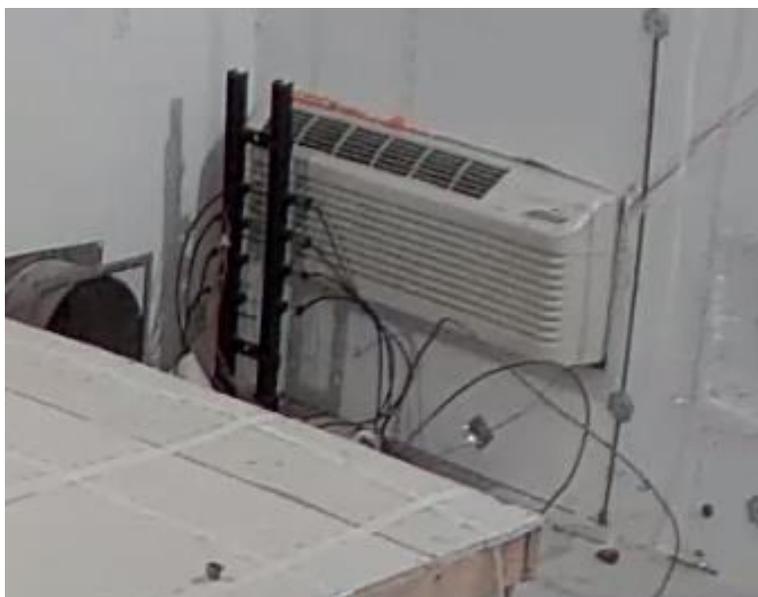
**Figure 90 – PTAC installation in test MPTAC01. The PTAC is positioned 3 inches away from the side wall.**

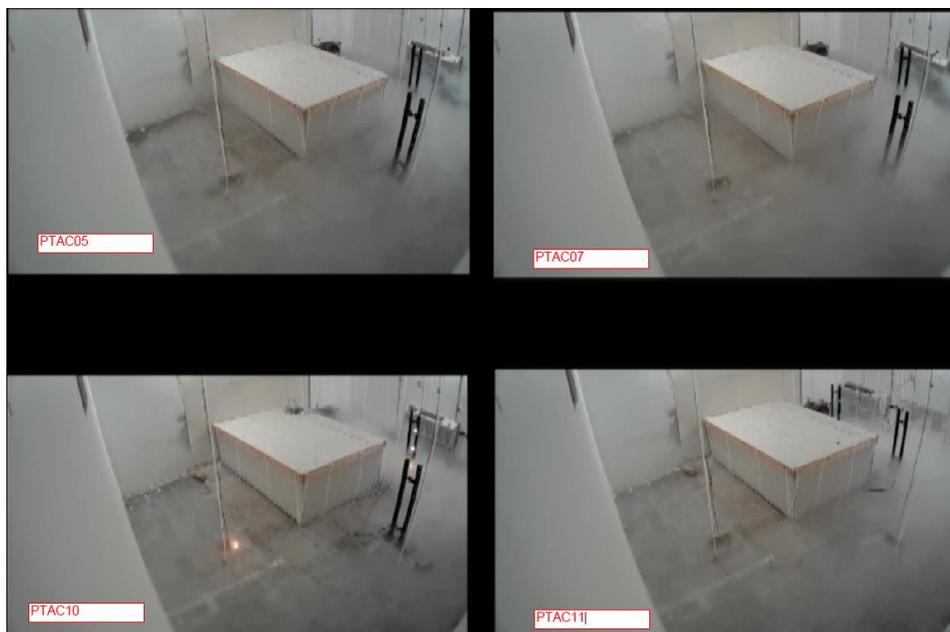
- In PTAC09 the discharge from the left side of the coil face was directed primarily toward the floor. This resulted in higher concentrations than in tests 6 and 8, but the video shows a sweeping action which directed the refrigerant away from the front of the PTAC and resulted in lower concentrations than in PTAC04.
- In PTAC12 the PTAC was moved to the far left of the room as shown in Figure 88. The discharge tube remained on the left side of the PTAC unit. Similar to PTAC09, the discharge jet initiated a momentum driven circulation in the room that swept refrigerant away from the front of the PTAC. The peak refrigerant concentration was lower than the four other tests.

Figure 93 – Comparison of R-452B videos at 35 seconds after the start of release

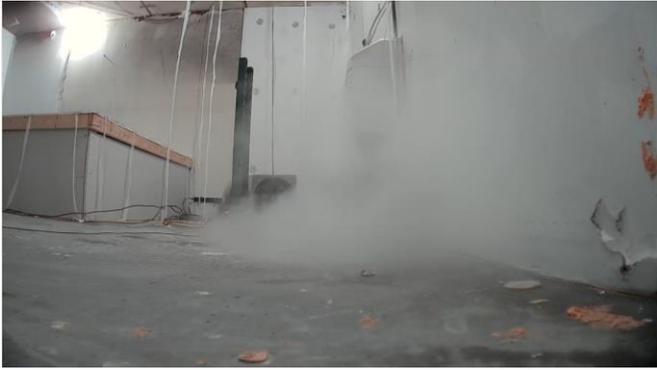
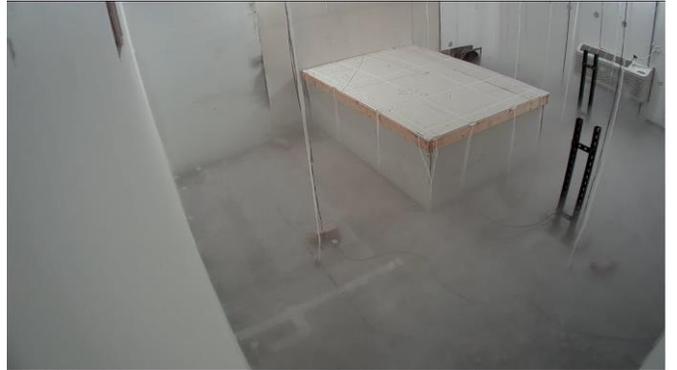
**Figure 94 – Data from PTAC04**

Floor level view at 3 seconds after the start of the discharge

Ceiling camera view at 56 seconds after the start of discharge.

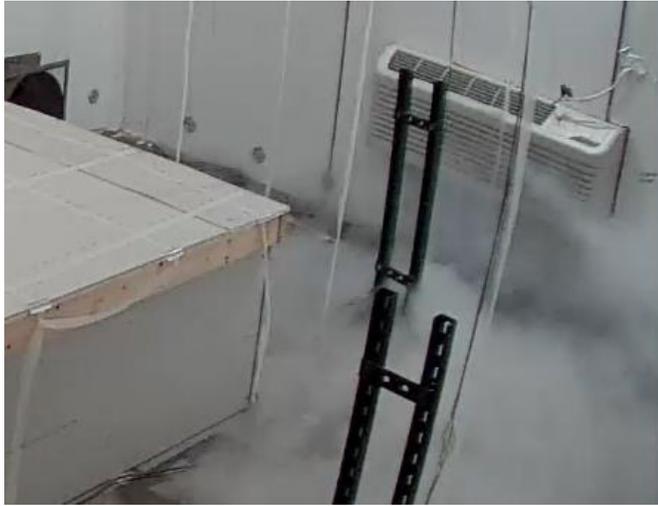
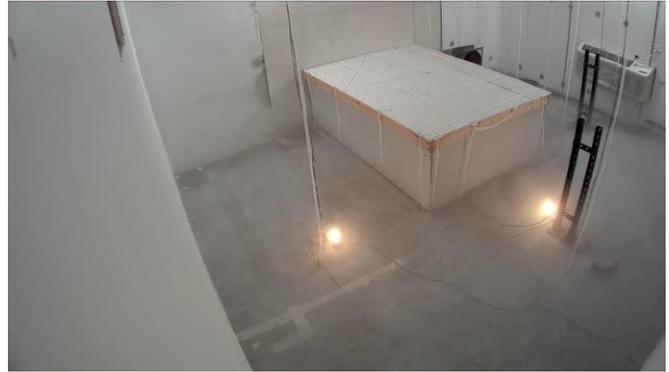
**Figure 96 – Data from PTAC06**

The purpose of this test was to attempt ignition of the discharged refrigerant at the time of maximum concentration determined in the PTAC04 test. Because of potential exposure to combustion products, ignition had to be delayed to 83 seconds to give time for the technician to exit the test area after completing the refrigerant discharge. Selected data from this test are shown in Figure 96.

Ceiling camera view at 3 seconds after the start of the discharge. The jet moving to the right was due to the discharge impinging on a vertical support of the grill face.

Ceiling camera view at ignition of candles and electric arcs 83 seconds after the start of discharge. Ignition time was delayed by 27 seconds to give time for the technician to leave the test room.

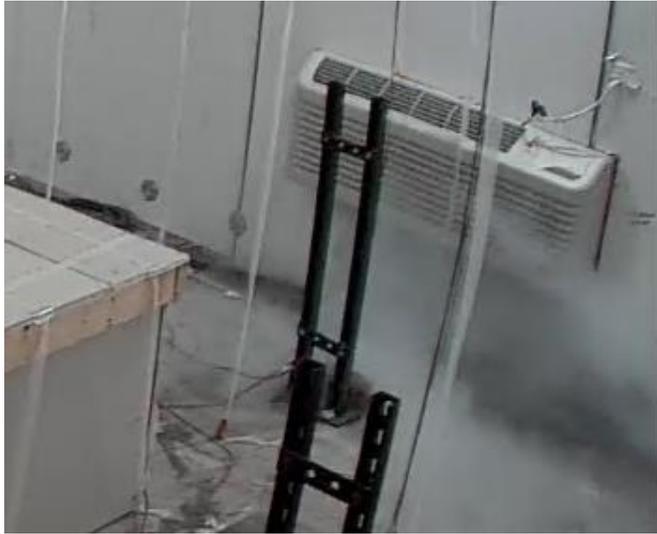
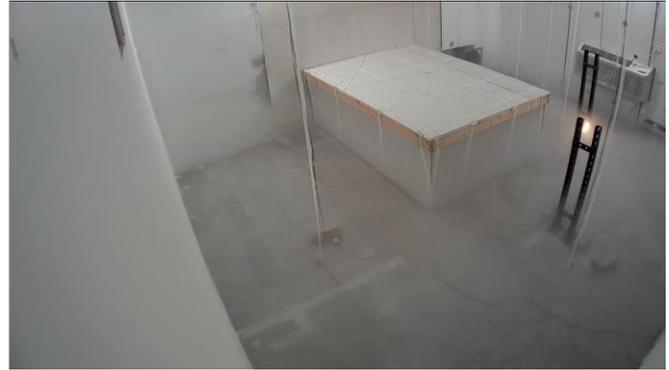
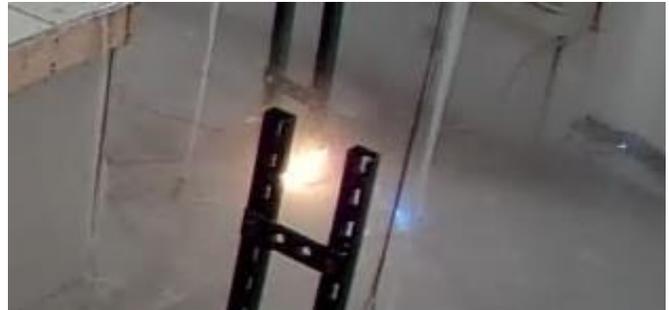
**Figure 97 – Data from PTAC07**

The purpose of this test was to attempt ignition of the discharged refrigerant at the time of maximum concentration determined in the PTAC04 test. Due to safety concerns ignition had to be delayed to 83 seconds to give time for the technician to exit the test area after completing the refrigerant discharge. Selected data from this test are shown in Figure 97.

Ceiling camera view at 3 seconds after the start of the discharge. The jet moving to the right was due to the discharge impinging on a vertical support of the grill face.

Ceiling camera view at ignition of candles and electric arcs 57 seconds after the start of discharge.

A small refrigerant flame was observed near location A. The cheesecloth was not ignited. The total flaming time for the refrigerant flame was 3 seconds.

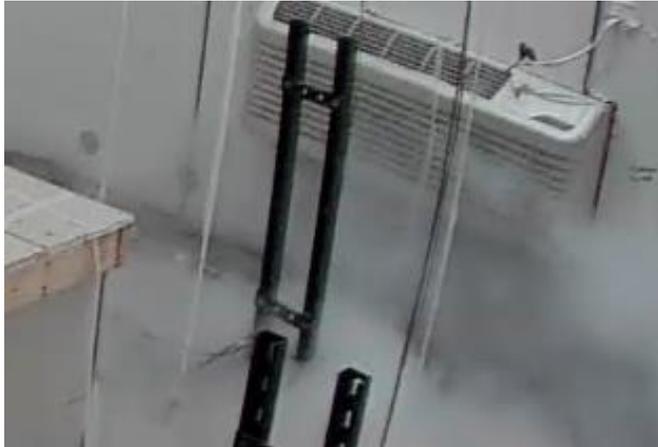
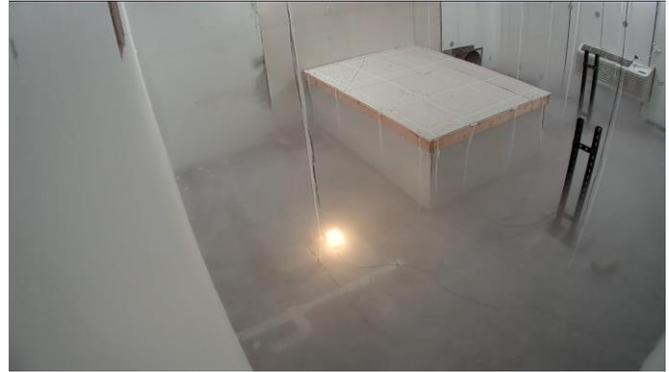
**Figure 98 – Data from PTAC08**

The purpose of this test was to attempt ignition of the discharged refrigerant at the time of maximum concentration determined in the PTAC04 test. Because of potential exposure to combustion products, ignition had to be delayed to 74 seconds to give time for the technician to exit the test area after completing the refrigerant discharge. Selected data from this test are shown in Figure 98.

Ceiling camera view at 3 seconds after the start of the discharge. The jet moving to the right was due to the discharge impinging on a vertical support of the grill face.

Ceiling camera view at ignition of candles and electric arcs 74 seconds after the start of discharge. Ignition time was delayed by 54 seconds to give time for the technician to leave the test room after closing the manual discharge valves.

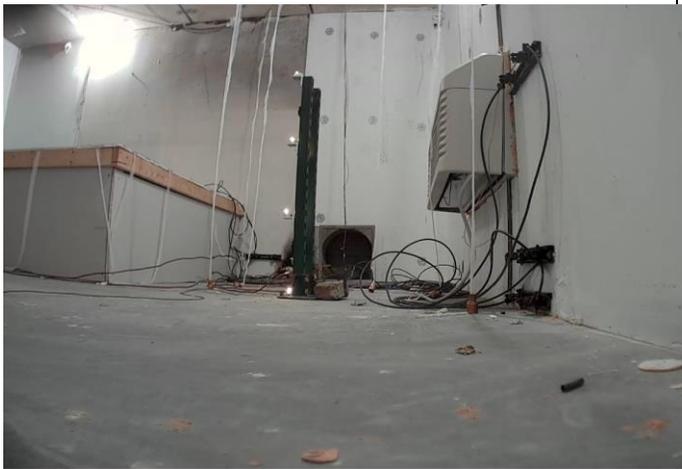
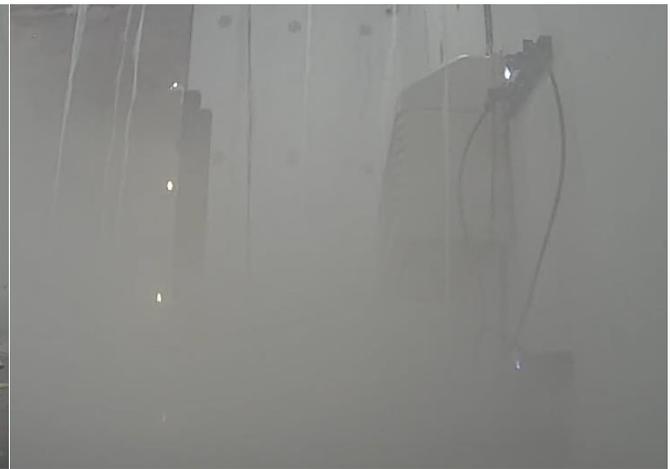
Figure 99 – Data from PTAC09

The purpose of this test was to attempt ignition of the discharged refrigerant with the candles ignited before the start of the discharge. Beginning with this test and the remainder of this series, the discharge tube was moved to the left side of the coil face, angled toward the floor, and placed such that the discharge did not impact a vertical support in the grill face. Supplementary pre-lit candles were added at location A (1, 12, 24, and 36 inches). An additional electric arc was added at location A at 24 inches above the floor. Selected data from this test are shown in Figure 99.

Floor camera view showing additional candles at location A and an additional electric arc at 24 inches.

Floor camera view at 51 seconds after the start of the discharge. The discharge was completed 38 seconds after the flow had started. The electric arcs were activated 3 seconds before this frame. The 24 inch electric arc shows some flaring, but there was no flaring at any other location. The candle at 1 inch height is nearly obscured by the mist.

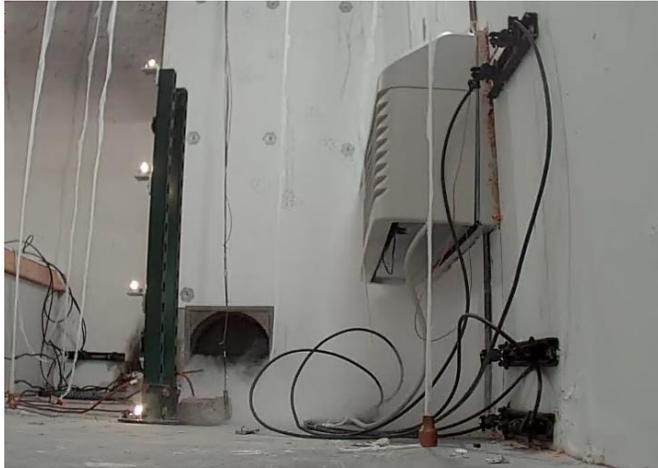
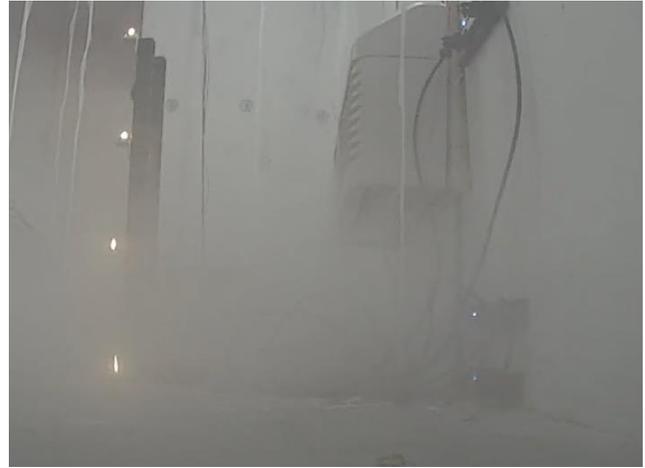
**Figure 100 – Data from PTAC10**

Floor camera view showing additional candles at location A and an additional electric arc at 24 inches. This frame is taken 2 seconds after the start of the discharge.

Floor camera view at 60 seconds after the start of the discharge and the technician had left the area. The electric arcs were started 19 seconds before this frame. All candles and electric arcs showed signs of flaring during the period.

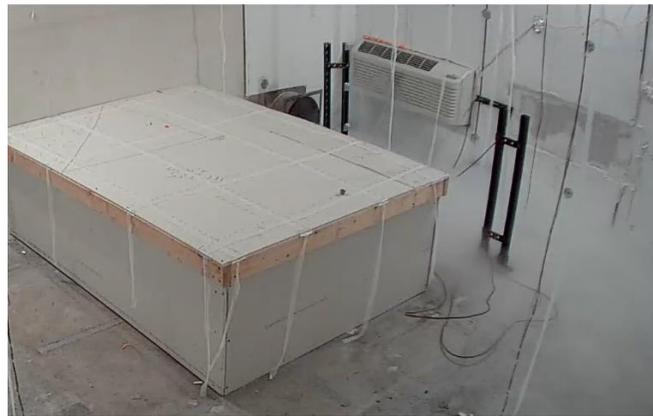
Figure 101 – Data from PTAC11

Ceiling camera view 10 seconds after the beginning of the discharge. While not apparent in a still frame, the video shows that discharge location near the corner of the room is directing the mist away from that corner and drawing in fresh air from above the bed.

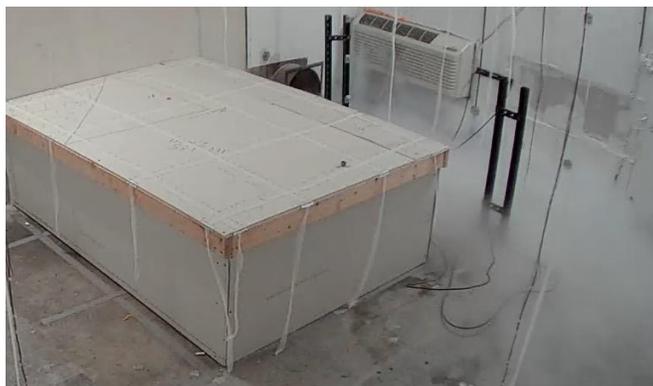
**Figure 102 – Data from PTAC12**

Ceiling camera view 10 seconds after the beginning of the discharge. While not apparent in a still frame, the video shows that the discharge location near the corner of the room is sweeping the mist away from that corner and entraining in fresh air from above the bed.

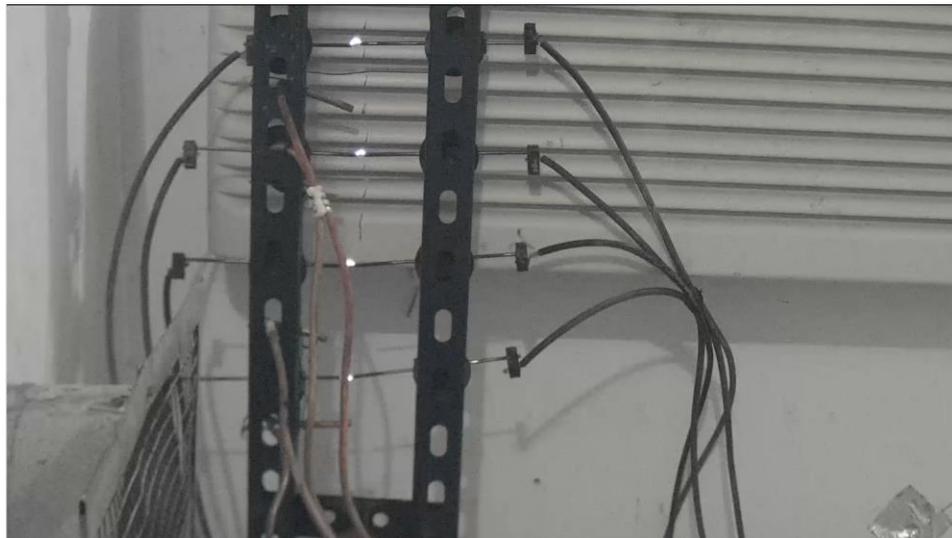
This modified PTAC test was designed to place electric arcs in the discharge stream directly in front of the discharge tube embedded in the coil face. One opinion that had been expressed was that it is hard to have sustained combustion of low burning velocity refrigerants when the velocity of the surrounding air is many times the burning velocity. The PTAC tests had been completed and the equipment remained in place. This additional test was conducted to see what would happen when an ignition source is in the high velocity refrigerant stream where the refrigerant concentration is well above the LFL. Figure 103 shows a close-up of this arrangement. The refrigerant sampling tubes were placed at 12, 16, 20, and 24 inches above the floor. The electric arcs were placed at 14, 18, 22, and 26 inches above the floor. Because of potential interference from the electric arcs, the thermocouple trees were placed as shown in Figure 104.

**Figure 103 – Electric arcs and refrigerant sampling tubes immediately in front of discharge location**

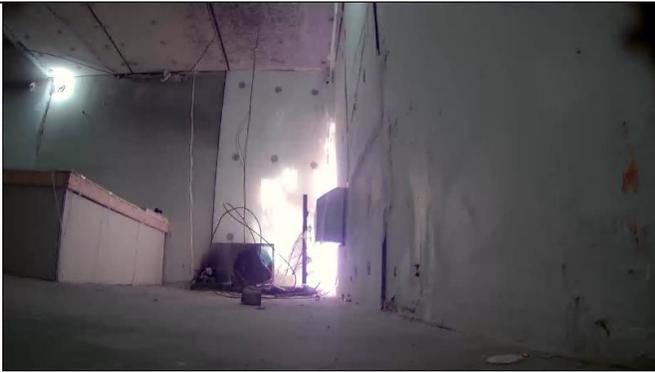
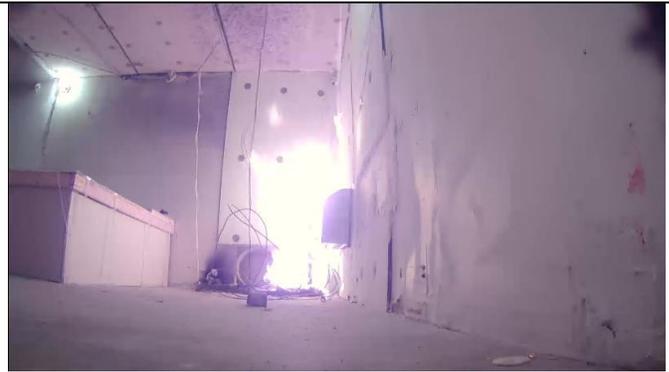
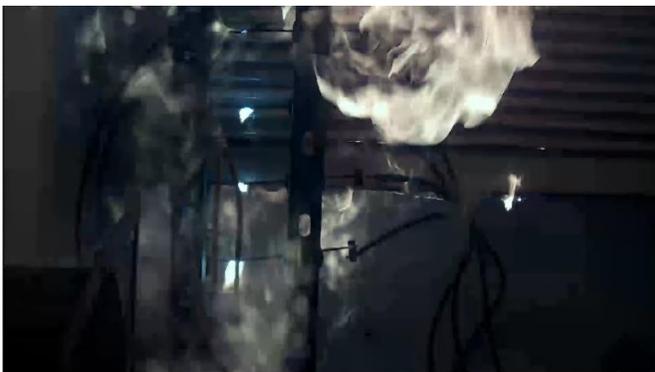
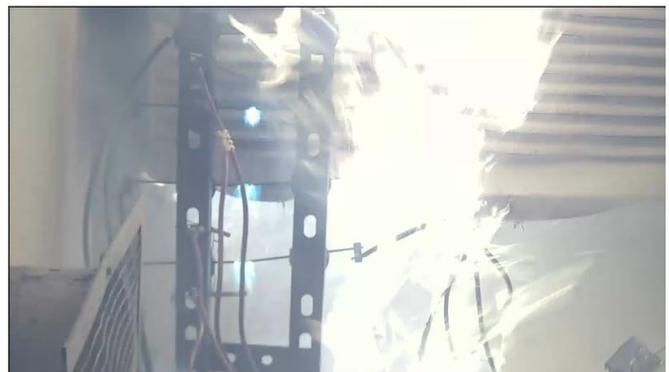
Figure 105 – Data from MPTAC01

Floor camera view 7 seconds after start of discharge

Floor camera view 30 seconds after start of discharge

Camera in front of PTAC showing flames extending downward from the electric arcs due to the force of the discharge jet. (20 seconds after start of discharge)

Camera in front of PTAC 30 seconds after start of discharge showing the start of one large flare. Six frames later (0.2 seconds), this camera view was washed out due to the size of the flame.

Selected data from this test are shown in Figure 105.

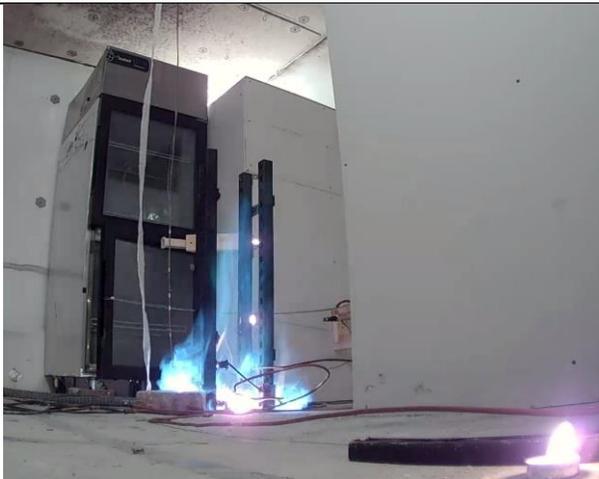
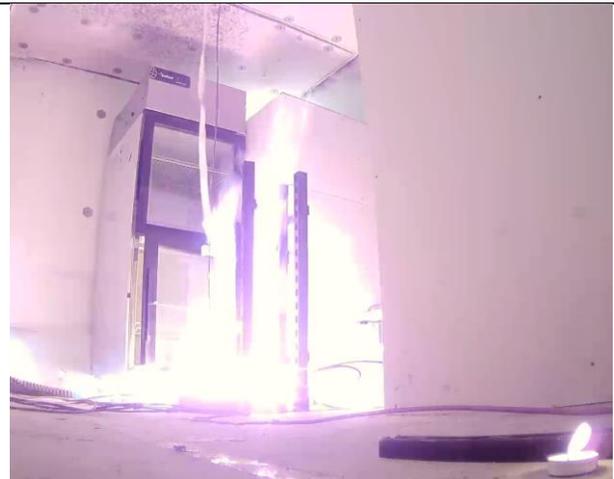
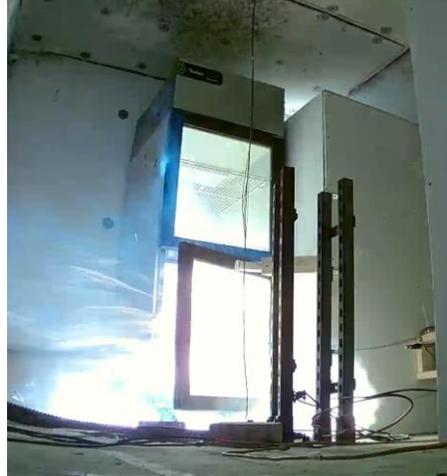
**Figure 109 - Test Results for Reach-in Cooler - Cooler02**

Flames 3 seconds after the reach-in cooler door was opened.

Flames 4s after reach-in cooler door - the fire size grew rapidly.

Flames 6s after reach-in cooler door; the flaming spread into the reach-in cooler.

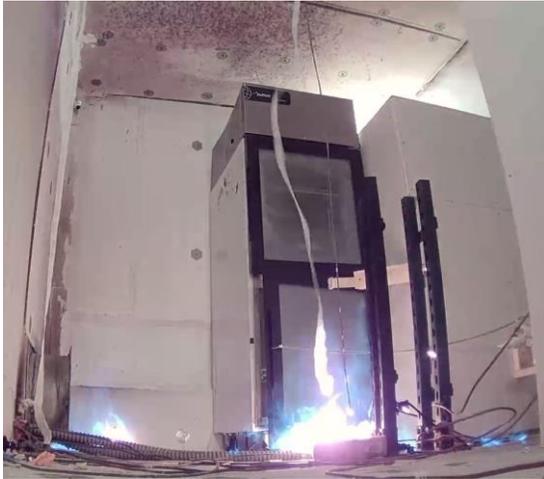
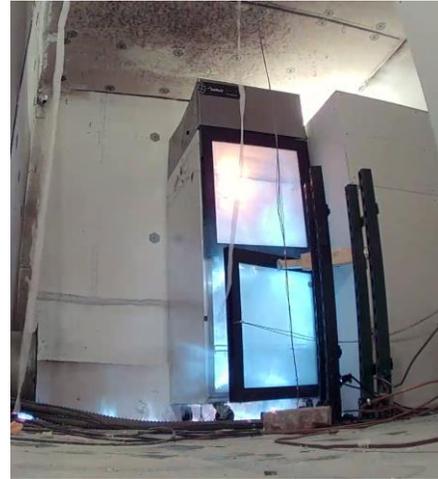
**Figure 111 - Test Results for Reach-in Cooler - Cooler04**

Ignition of the refrigerant gas occurred 3 seconds after the reach-in cooler door was opened. The flames continued for approximately 9 seconds. The test results are presented in Figure 111.

Ignition of refrigerant 6 seconds after the reach-in cooler door was opened showing flaming in front and in corner.

Flames 10s after reach-in cooler door is opened enter the cooler

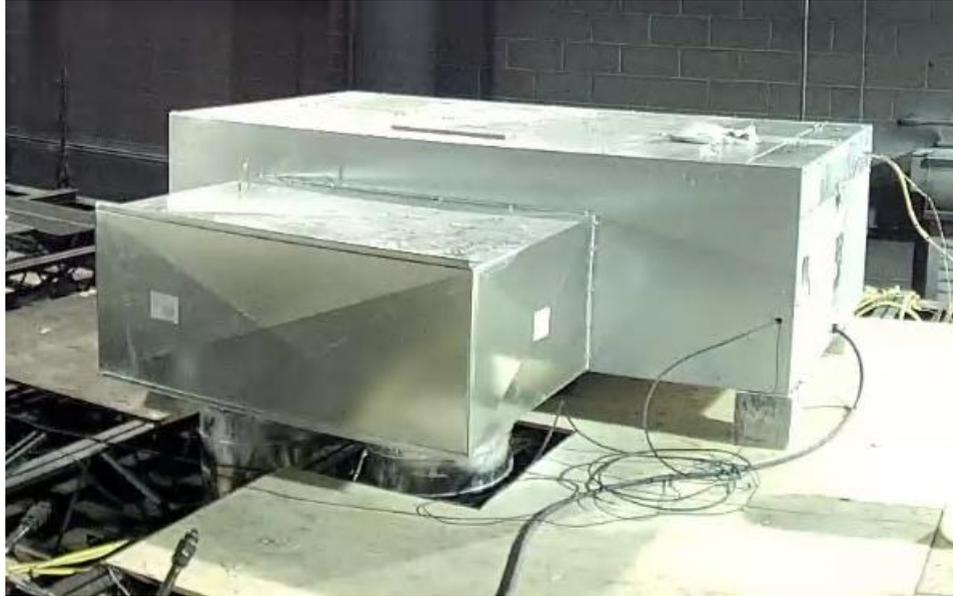
**Figure 114 – Roof top unit (supply side)**

The commercial kitchen scenario involved the use of a roof top unit with duct work connected to the kitchen space below. Tests were conducted to represent a refrigerant leak in the evaporator. The kitchen dimensions were 14 x 16 x 8 ft. high. Objects representing work surfaces were located in the test area. The test setup is shown in Figure 112, Figure 113, Figure 114, and Figure 115.

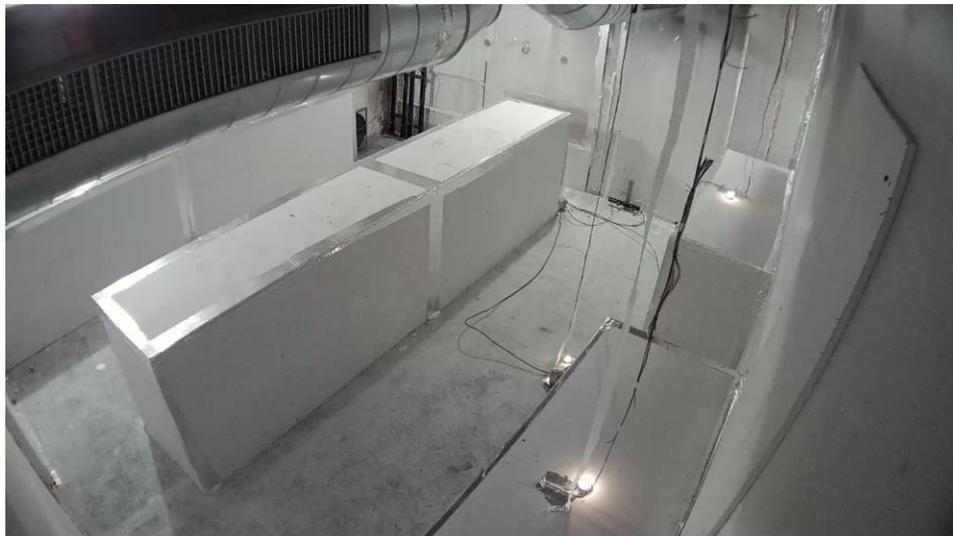
**Figure 115 - Camera view of kitchen with supply duct work (Locations D, B, and C from foreground to background)**

The locations of the instrumentation, and ignition sources were located in clusters at locations A, B, C, and D. The locations relative to the front and right walls are shown in Table 31.

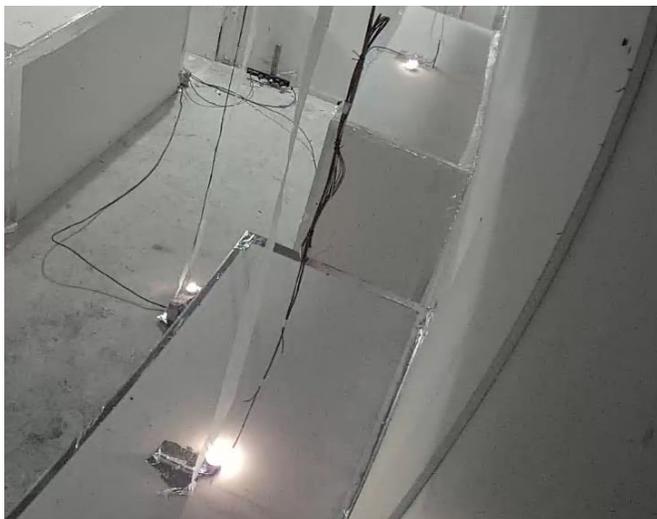
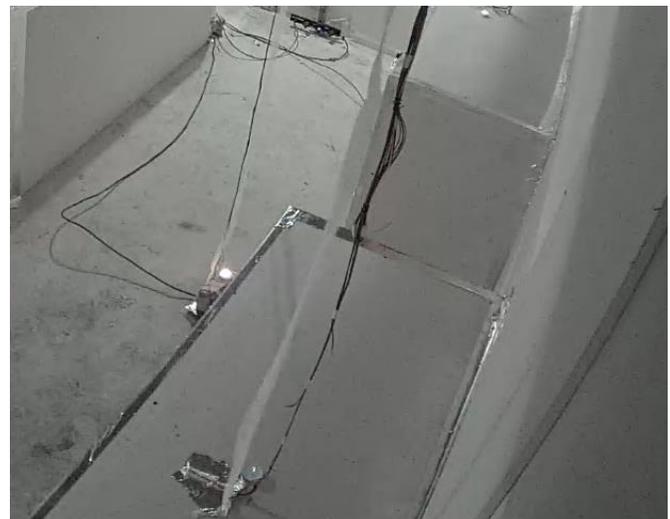
Figure 119 – Data from Kitchen01

There was no ignition during the test. The candles were extinguished shortly after the blower motor was started. The reason for the extinguishment would require further investigation. Shortly before the blower motor started there was increased flame size at the candles at locations A, C, and D. The candle at floor level (location B) remained lit throughout the test. Selected data from this test are shown in Figure 119.

Candles Flaring up at 31 seconds after the beginning of the discharge due to increased refrigerant concentration.

Candles at Locations A, C, D extinguished at 35 seconds after blower motor up to speed (26 Hz).

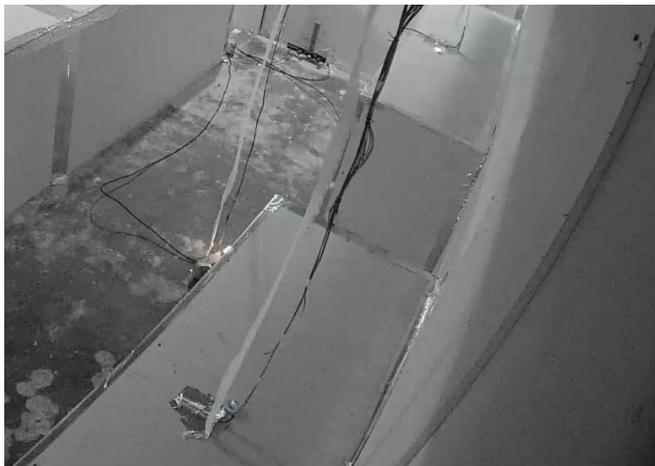
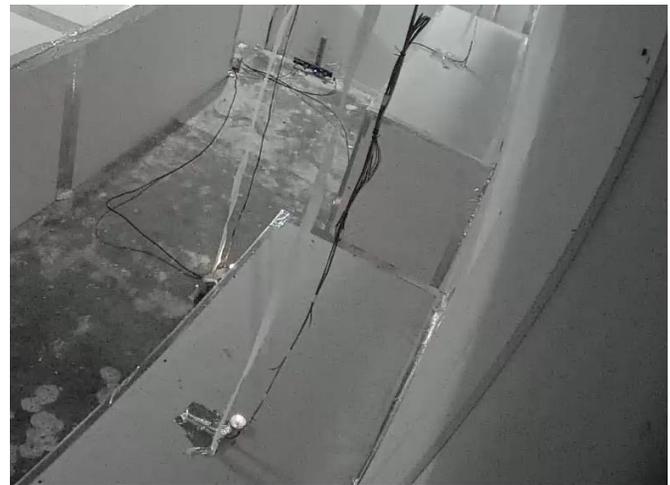
Figure 120 – Data from Kitchen02

Candle flickering at 34 seconds after the beginning of the discharge. The blower motor had been started 2 seconds prior.

Candle at Locations C extinguished at 42 seconds after the beginning of the discharge. The blower motor had been operating for 10 seconds. The candle at location A extinguished 11 seconds later.

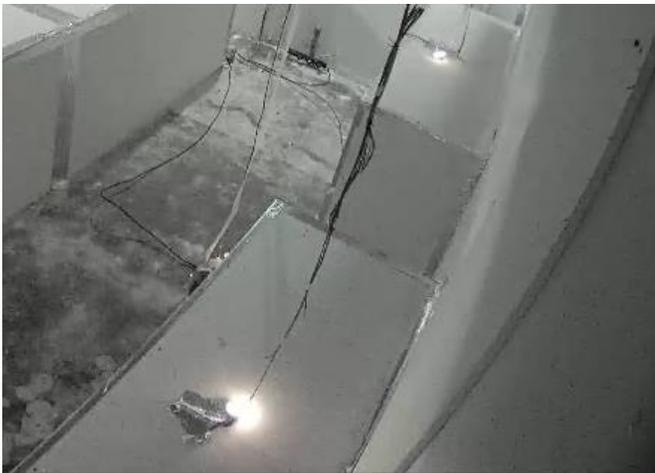
Candles flaring up at 23 seconds after the beginning of the discharge.

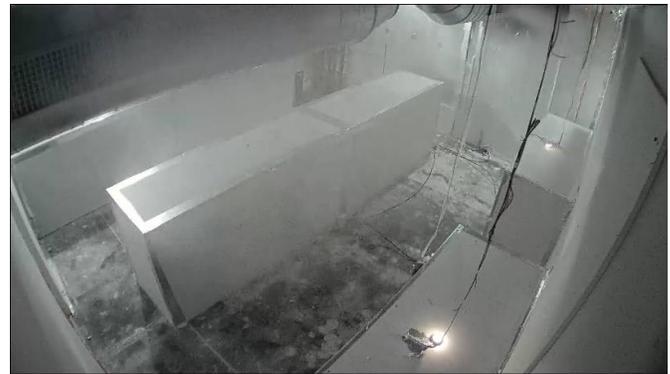
Figure 121 – Data from Kitchen03

Mist exiting the supply duct at 62 seconds after the beginning of the discharge. The blower motor had been started 2 seconds prior to this frame. Candles at locations C and D extinguished 17 seconds later. The candles at locations A and B remained lighted throughout the test.

There was no ignition during the test. The candles at locations C and D were extinguished shortly after the blower motor was started. From the video it appears that the candles were extinguished due to air movement caused by the blower motor. The candles at locations A and B remained lit throughout the test. Some flaring of the candles was observed in the 20 seconds after the beginning of the discharge. Selected data from this test are shown in Figure 121.

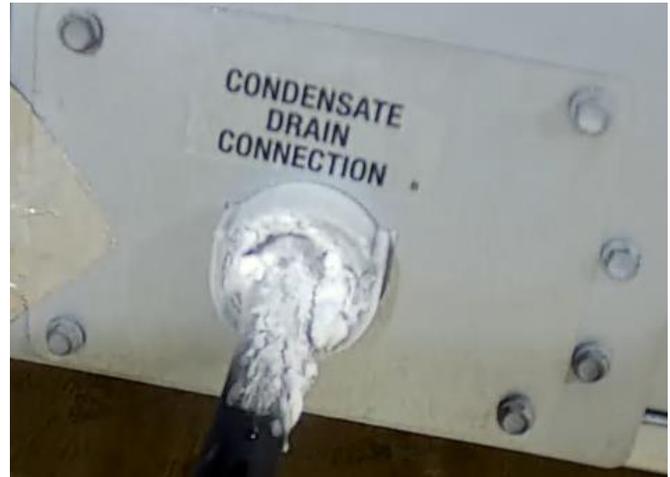
Condensate Drain on RTU showing maximum ice build up and condensation escaping through this route. The power cable for the fan motor was routed through the condensate drain.

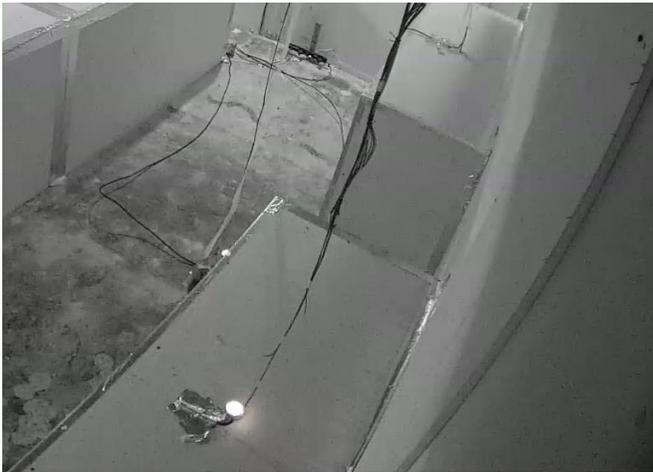
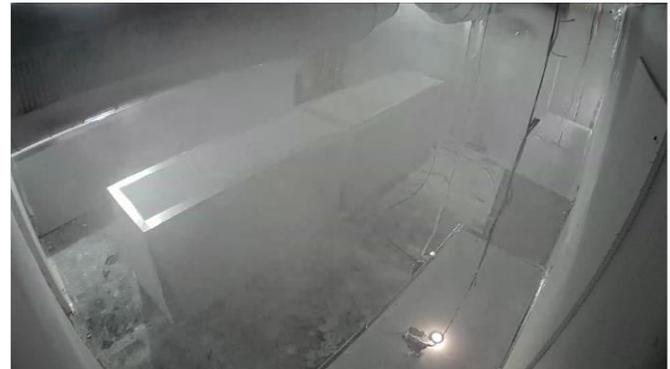
Figure 122 – Data from Kitchen04

The candle at location C extinguished 30 seconds after the beginning of the discharge. Candle at location D extinguished at 64 seconds (2 seconds after the blower was started). The candle at location A extinguished at 204 seconds. The candle at location B remained lit throughout the test. The candles were observed to flare up at 20 seconds after the beginning of the discharge.

Mist exiting the supply duct at 62 seconds after the beginning of the discharge. The blower motor had been started 2 seconds prior to this frame. The candle at location D extinguished 2 seconds later.

There was no ignition during the test. The candles at locations A, C, and D were extinguished at various times before and after the blower motor started. The reason for the extinguishment would require more experimentation. The candle at location B remained lit throughout the test. Selected data from this test are shown in Figure 122.

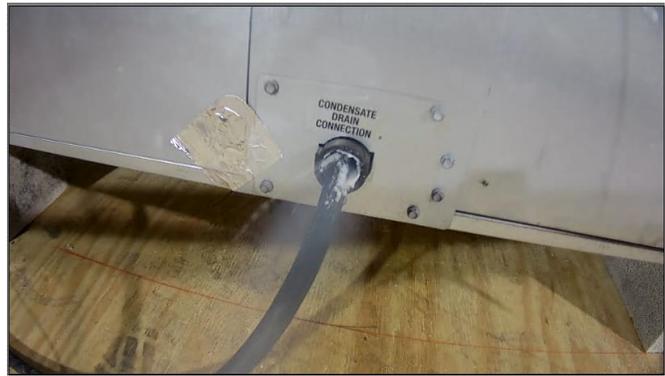
Condensate Drain on RTU

This frame shows ice buildup and a substance being ejected. It is not known whether this was ice, refrigerant or a mix of the two. The power cable for the fan motor was routed through the condensate drain.

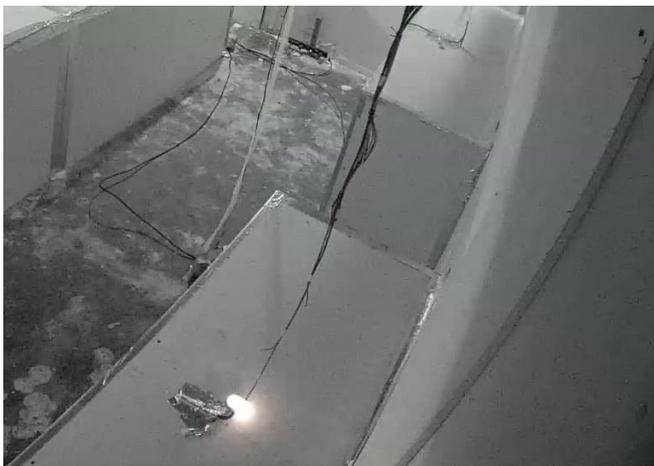
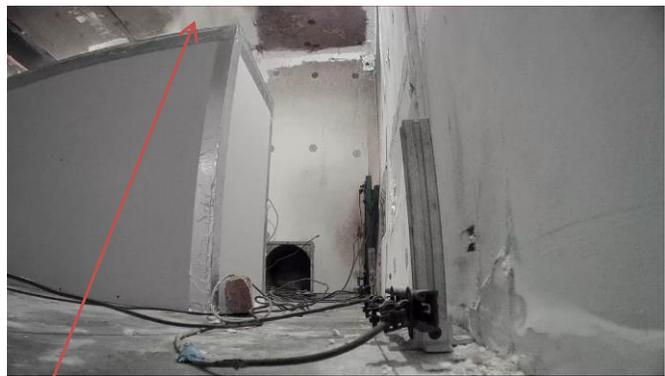
Figure 123 – Data from Kitchen05

The candles at location B and C flamed out before the beginning of the test. The candle at Location D flared up at 20 seconds after the beginning of the discharge. This candle extinguished 5 seconds later. The candle at location A extinguished at 204 seconds.

Mist exiting the supply duct at 62 seconds after the beginning of the discharge. The blower motor had been started 2 seconds prior to this frame. Flames about 1 inch in height were observed at the electric arc locations after the blower had been running for 5 seconds.

There was no ignition during the test. The candles at locations B and C extinguished before the test began. The candles at locations A and D flared up 20 seconds after the beginning of the discharge. The candle at location D extinguished at 29 seconds after the beginning of the discharge. The electric arc locations were observed have flames about 1 inch long attached to the arc after the blower motor was running for 5 seconds. The candle at location A extinguished 60 seconds after the blower motor was started. Selected data from this test are shown in Figure 123.

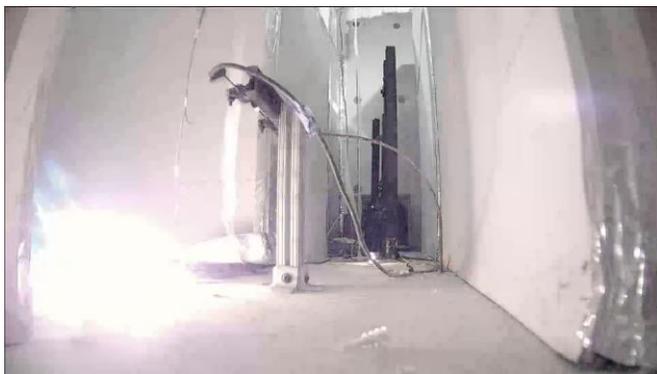
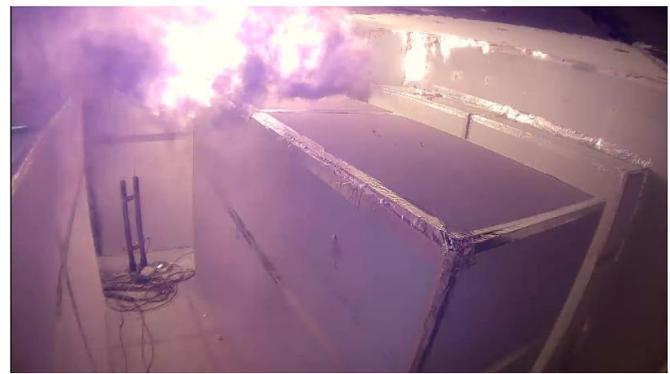
Figure 128 – Data from WALKIN08

Floor level view at 10 seconds after the start of the discharge. Localized flaming occurred at the electric arc locations.

Ceiling level view of flames at ceiling height 105 seconds after that start of the discharge.

In order to prevent a room-deforming overpressure, the door latch was disabled allowing the door to serve as a deflagration vent. This door was forced open during the test at the time of the first large ignition. Selected data from this test are shown in Figure 128.

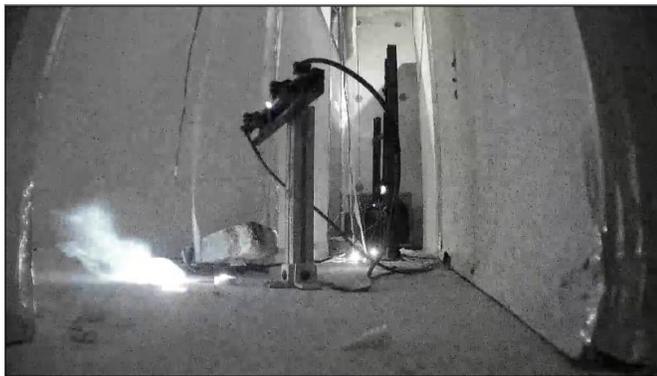
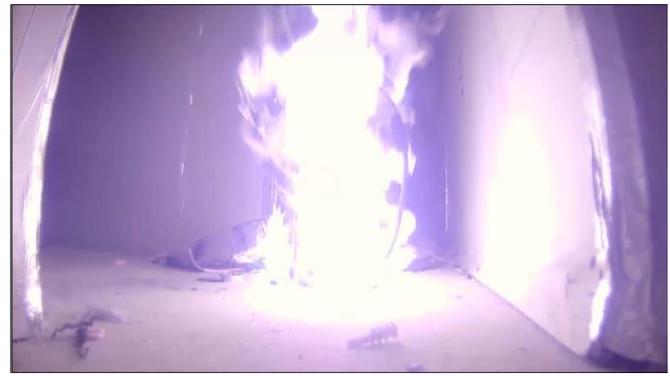
Figure 129 – Data from WALKIN09

Floor level view at of initial flaming at 13 seconds after the start of the discharge. Localized flaming occurred at the electric arc locations.

Floor level view at 21 seconds after the start of the discharge. Door was forced open by over pressure 4 seconds later.

In order to prevent a room-deforming overpressure, the door latch was disabled allowing the door to serve as a deflagration vent. This door was forced open during the test at the time of the first large ignition. Selected data from this test are shown in Figure 129.

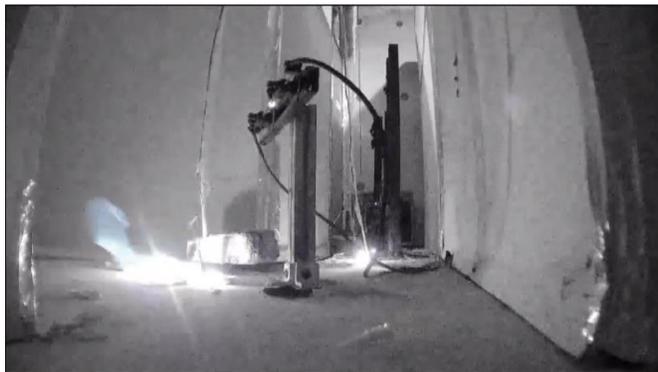
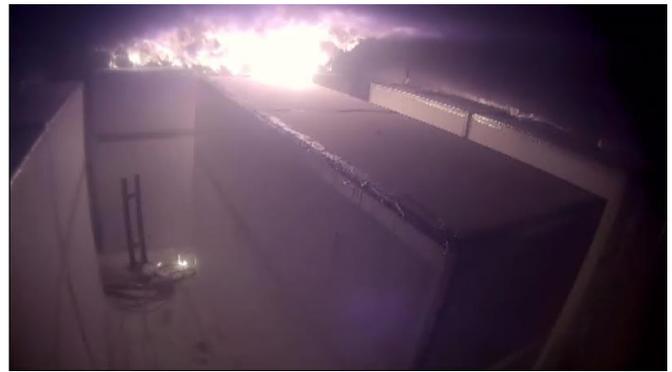
Figure 131 – Data from WALKIN11

Floor level view of the start of ignition at 18 seconds after the start of the discharge.

Ceiling level view of flames at ceiling height 93 seconds after that start of the discharge. The ceiling is obscured by smoke.

The door to the walk-in cooler was left open in this test compare with the door-closed test in the Walkin09 test. Selected data from this test are shown in Figure 131.

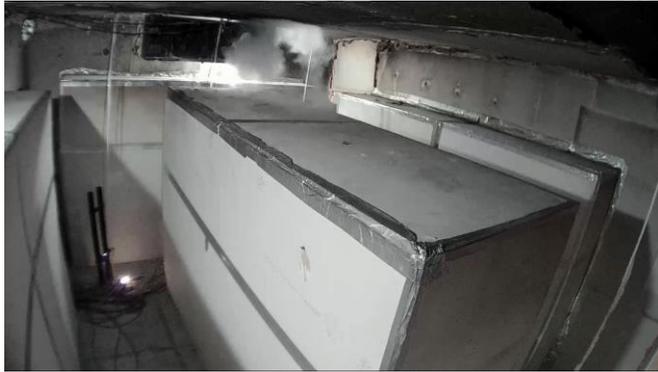
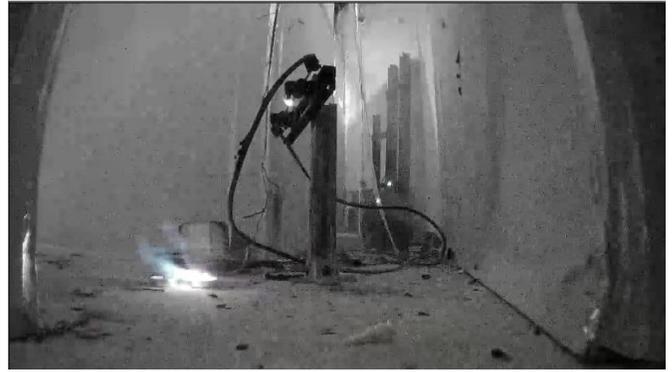
**Figure 132 – Data from WALKIN12**

Ceiling camera view of the discharge showing the condensation cloud at the ceiling level.

Floor camera view showing ignition at location C, 88 seconds after the start of the discharge.

In this test and the following two tests, the discharge locations was moved to the center of the coil face. The orientation of the discharge tube directed the discharge horizontally at the level of the unit cooler. The door to the walk-in cooler was closed. Selected data from this test are shown in Figure 132.

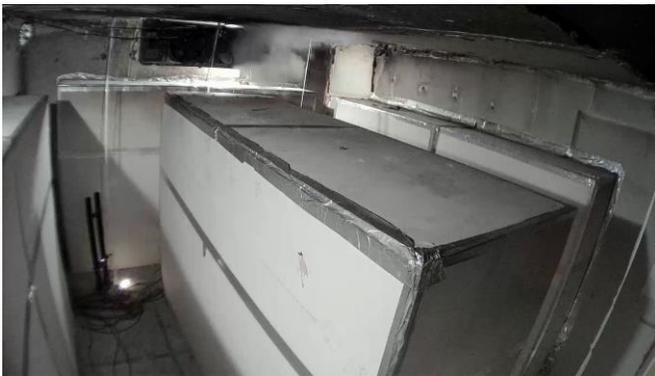
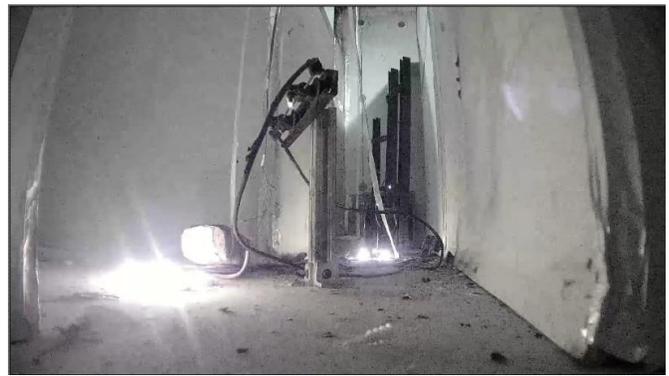
Figure 134 – Data from WALKIN14

Ceiling camera view of the discharge showing the condensation cloud at the ceiling level.

Floor camera view showing flaring at the candles and electric arc at location C and candles at location B.

This test is a repeat of the R-455A test in Walkin12 with the exception that the door to the walk-in had been left open. An additional kilogram was added to the pressurizer and release tanks in order to prevent the low pressure seen at the end of the Walkin12 test. Selected data from this test are shown in Figure 134.
