**Air-Conditioning, Heating and  
Refrigeration Technology Institute**

AHRTI Report No. 9007-01

BENCHMARKING RISK BY WHOLE ROOM SCALE LEAKS AND IGNITIONS TESTING OF A2L REFRIGERANTS

UL LLC

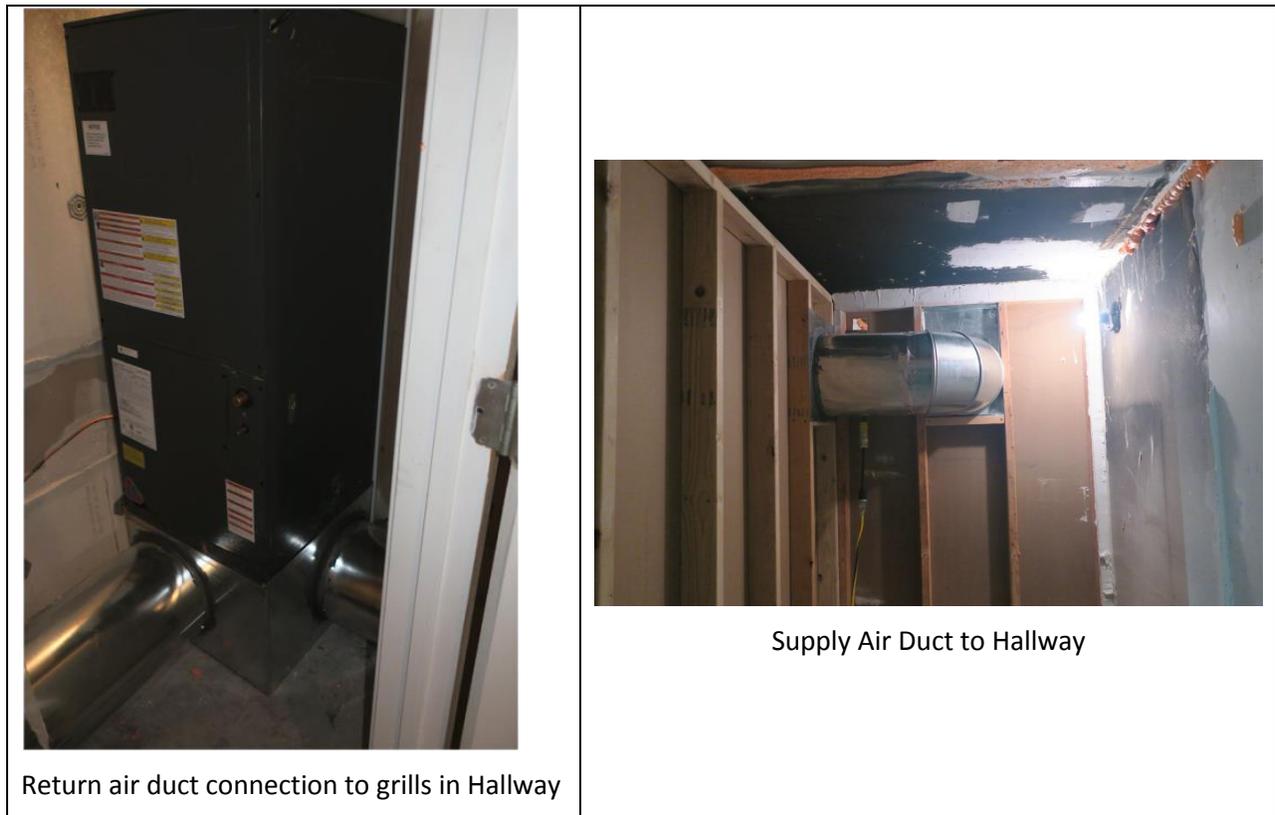
**Figure 136 – Return Air and Supply Ducts Air connecting to Air Conditioning Unit**

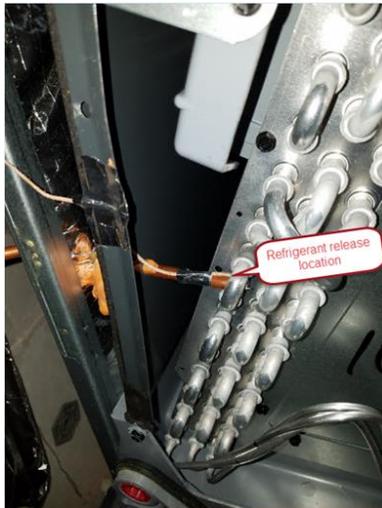
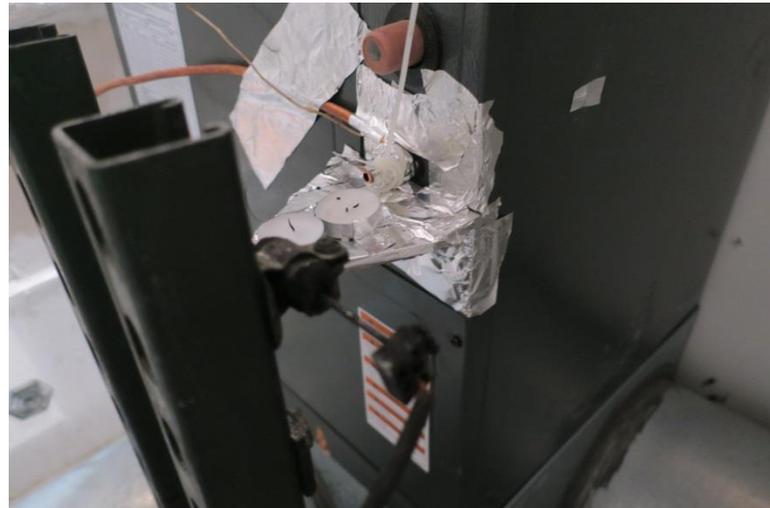
**Figure 137 – Refrigerant Release Location for Residential A/C Scenarios**

Refrigerant release location for leakage in A-Coil Scenario

Refrigerant release location for service error scenario

Photographs of the refrigerant release locations are shown in Figure 137.

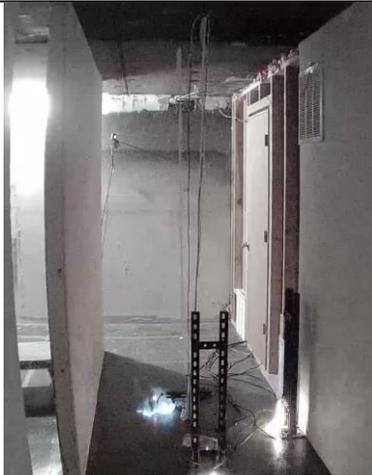
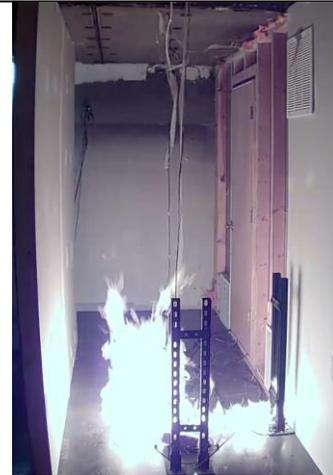
Ignition of the refrigerant 12s after refrigerant release.

Flames 20s after refrigerant release.

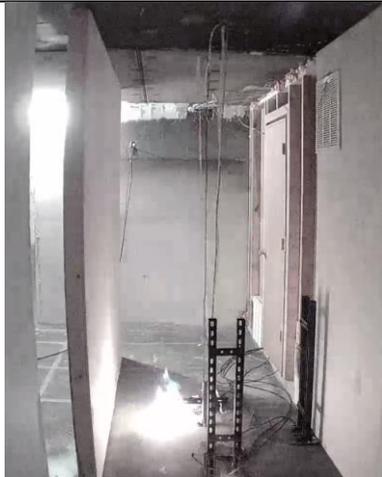
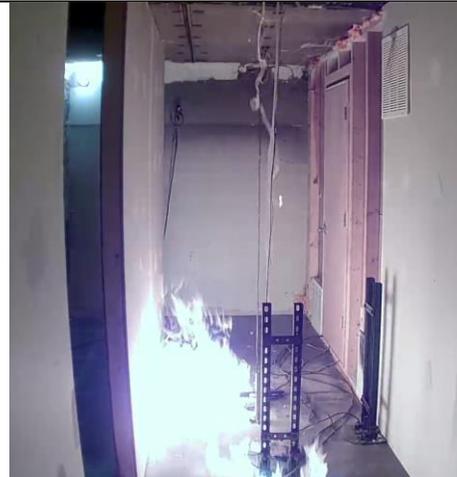
Ignition of the refrigerant 12s after refrigerant release.

Flames 20s after refrigerant release.

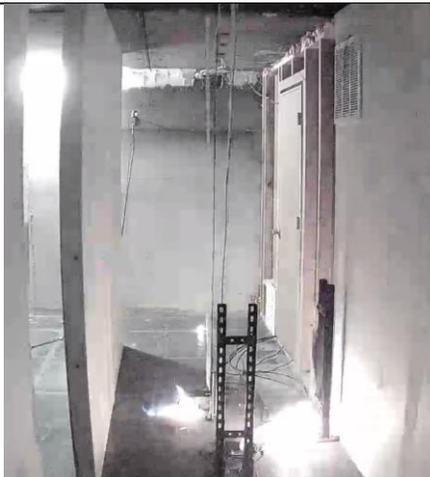
Ignition of the refrigerant 12s after refrigerant release.

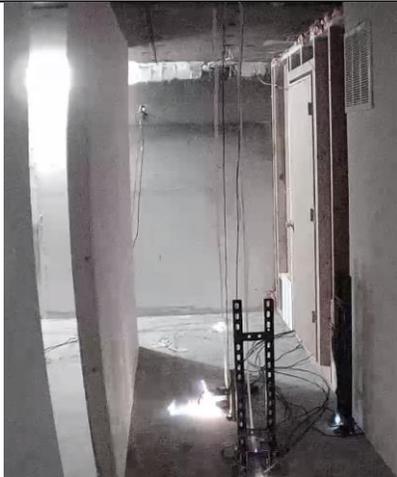
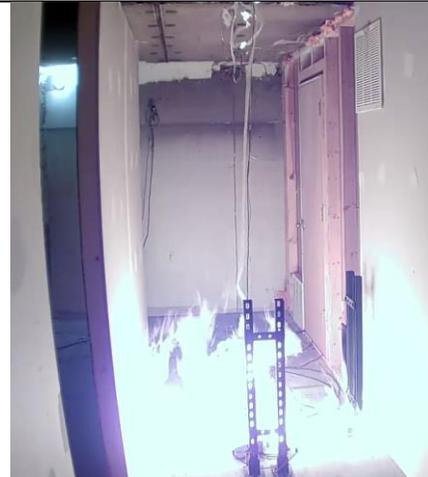
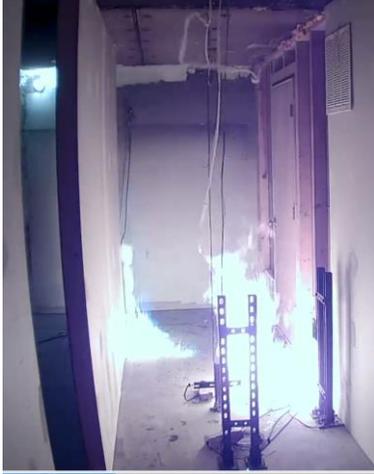
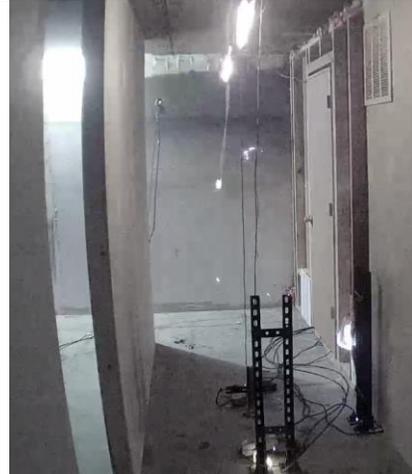
**Figure 142 - Test Results for Residential A/C Res05**

Ignition of the refrigerant 12s after refrigerant release.

Flames 18s after refrigerant release; flames moves toward the return air grill.

27s after refrigerant release; flame spread observed on the floor in the hallway toward the right wall.

60s after refrigerant release; cheese cloth ignition all the way to the ceiling; all flaming ceased 76s after refrigerant release.

Ignition occurred 12s after refrigerant release was initiated. The flaming continued for approximately 62s. The flames spread along the hallway and also towards the return grill. The test results are presented in Figure 142.

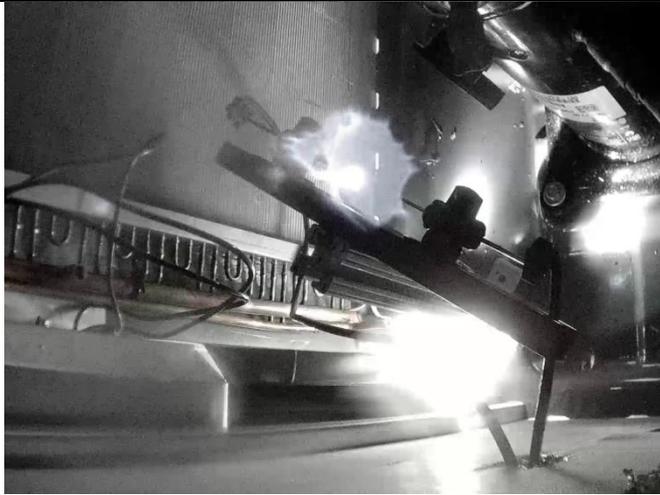
Initial Position of Molded Plug

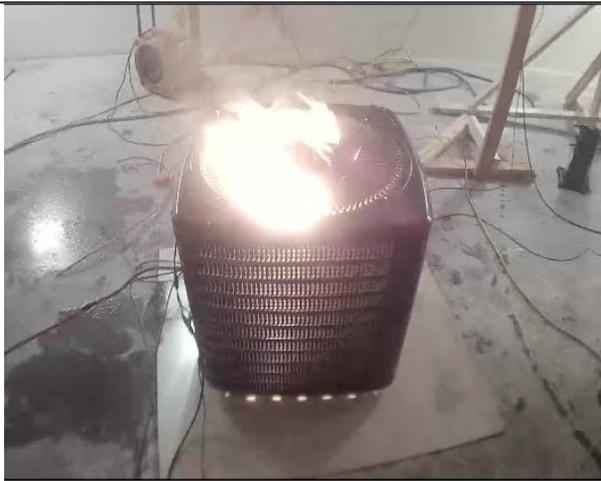
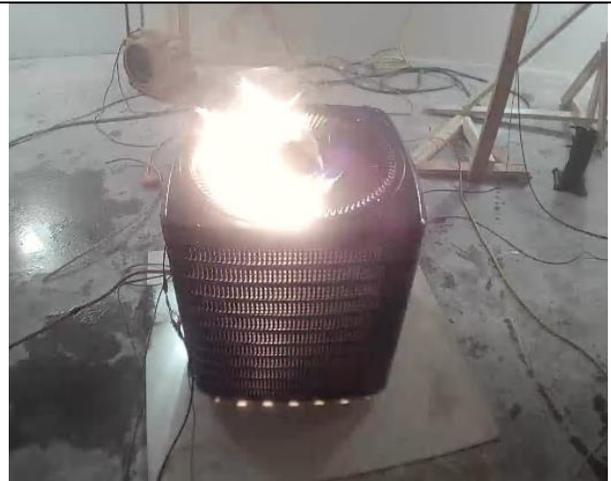
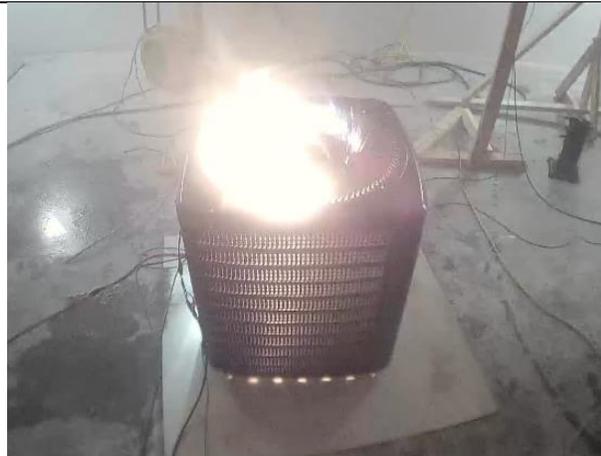
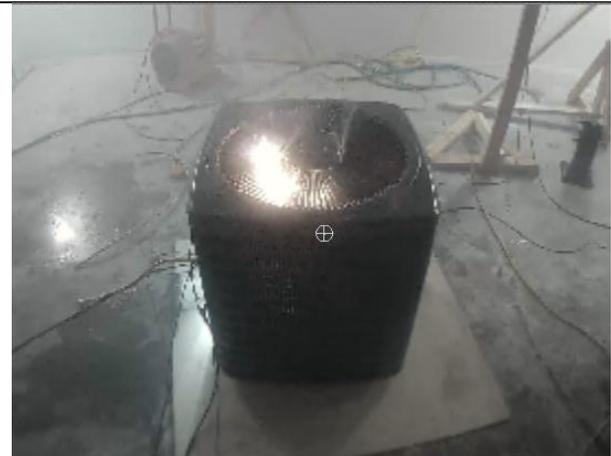
**Figure 153 – Data from Term02**

Video still showing ignition (55 s after release start)

Video still showing ignition (62 s after release start)

Video still showing ignition (82 s after release start)

Video still showing ignition (102 s after release start)

The test results are presented in Figure 153.

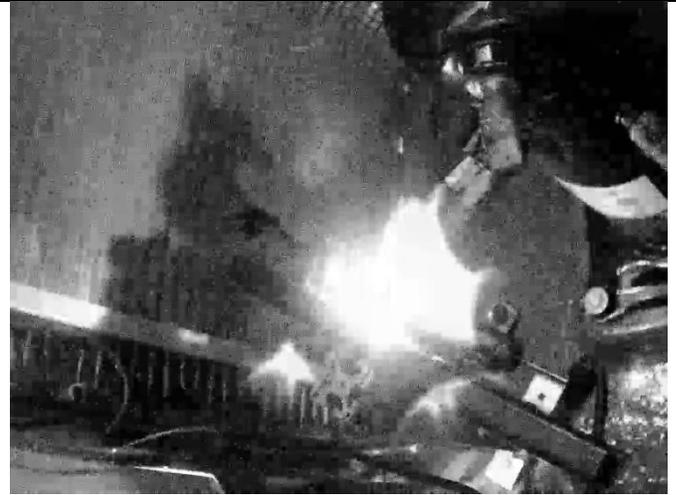
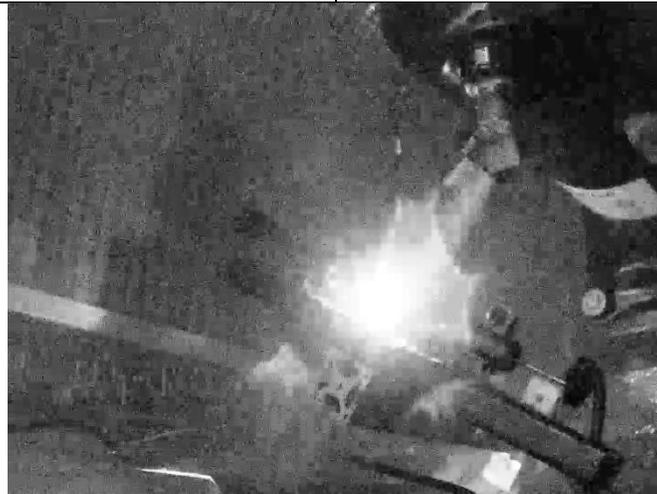
**Figure 155 – Data from Term04**

Molded Plug no longer attached to compressor (10s after release)

Release of Refrigerant (40s after release start)

The test results are presented in Figure 155.

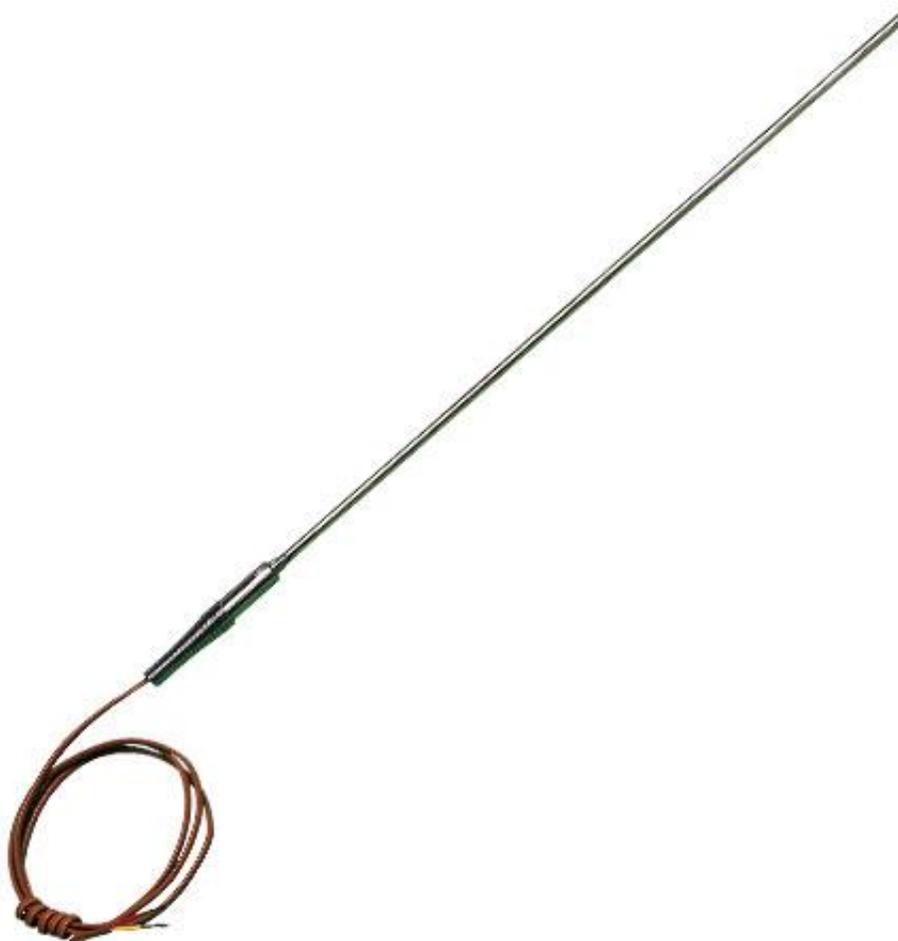
Figure 157 - TC\TJ36-CAXL-18U-48

Ungrounded 1/8 inch diameter type K thermocouples were used to measure temperatures in the release and pressure tanks as well as the surrounding water baths.

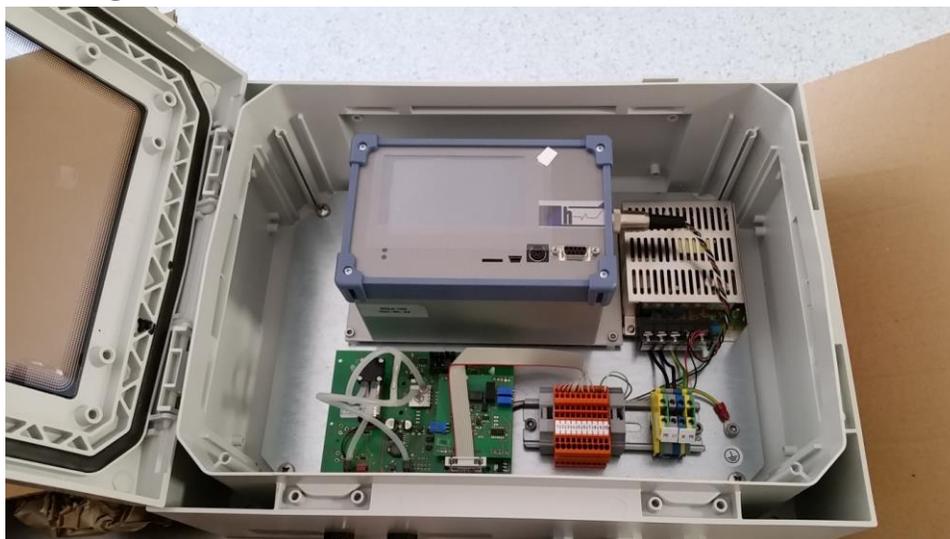
**Figure 158 - GA\Henze-Hauck Electronics**

The Henze-Hauck electronics package provides power for heating to the sensor and processes the signal. Four separate systems, one accompanying each sensor, were in use.

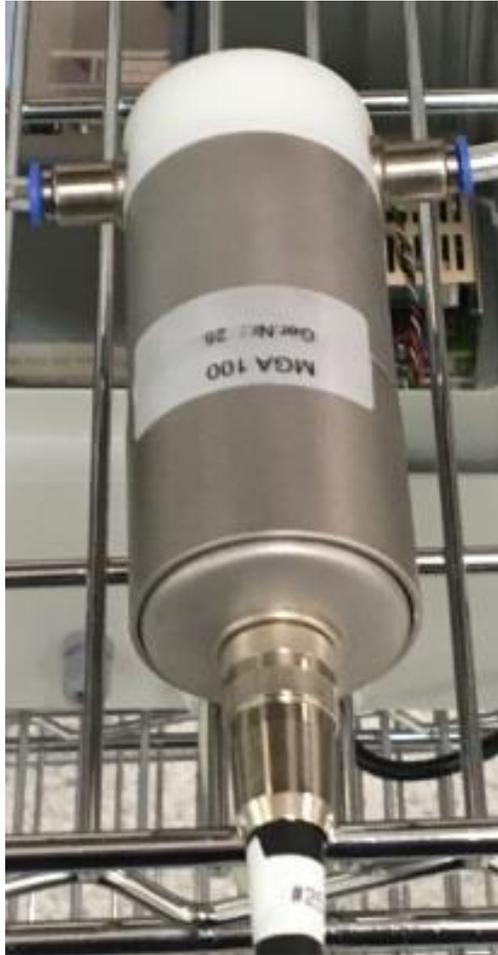
**Figure 159 - GA\Refrigerant Sensor**

The Henze-Hauck refrigerant sensor outputs a millivolt signal from a bridge circuit that responds to differences in gas conductivity. The sensors were calibrated for each refrigerant used in the test program.

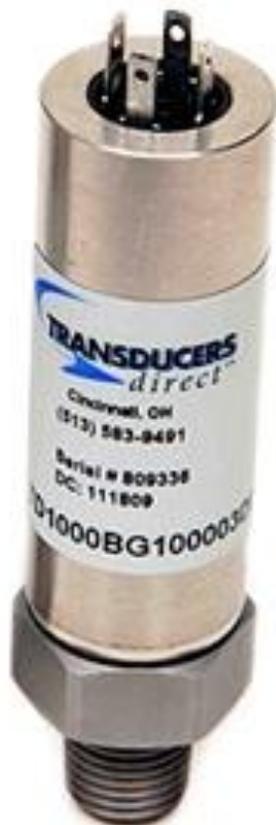
Figure 161 - PT\TD1000

Pressure transducers were used on the Release and Pressurizer tanks.

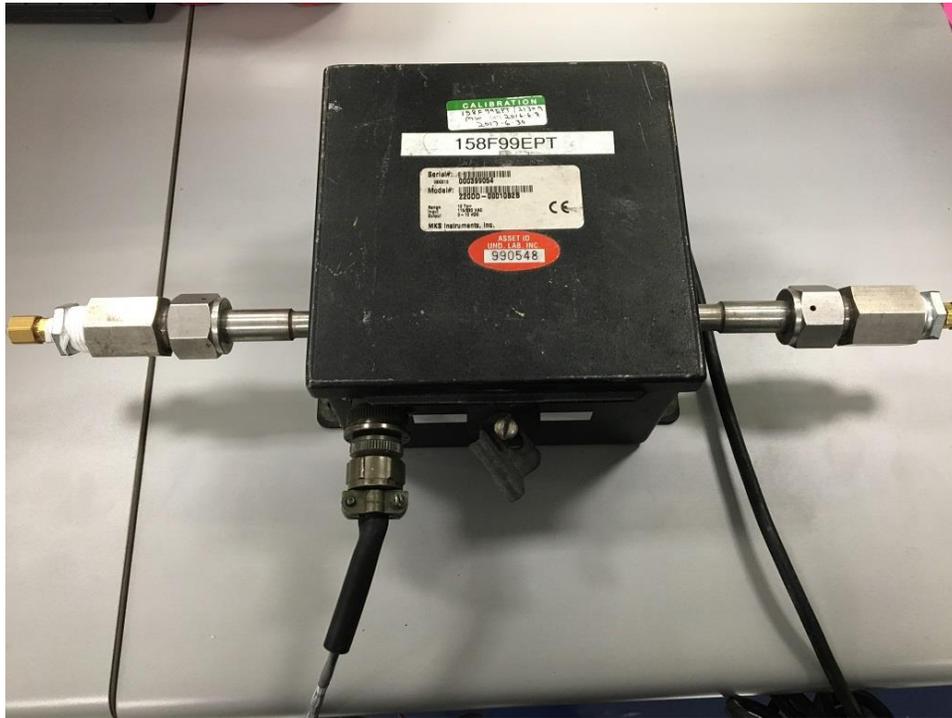
Figure 162 - PT\220DD 10 Torr

The 10 Torr pressure transducers were used to monitor the pressure difference between the test room and various locations. One instrument was later used to monitor differential pressure across the blowers (Residential and Kitchen scenarios).

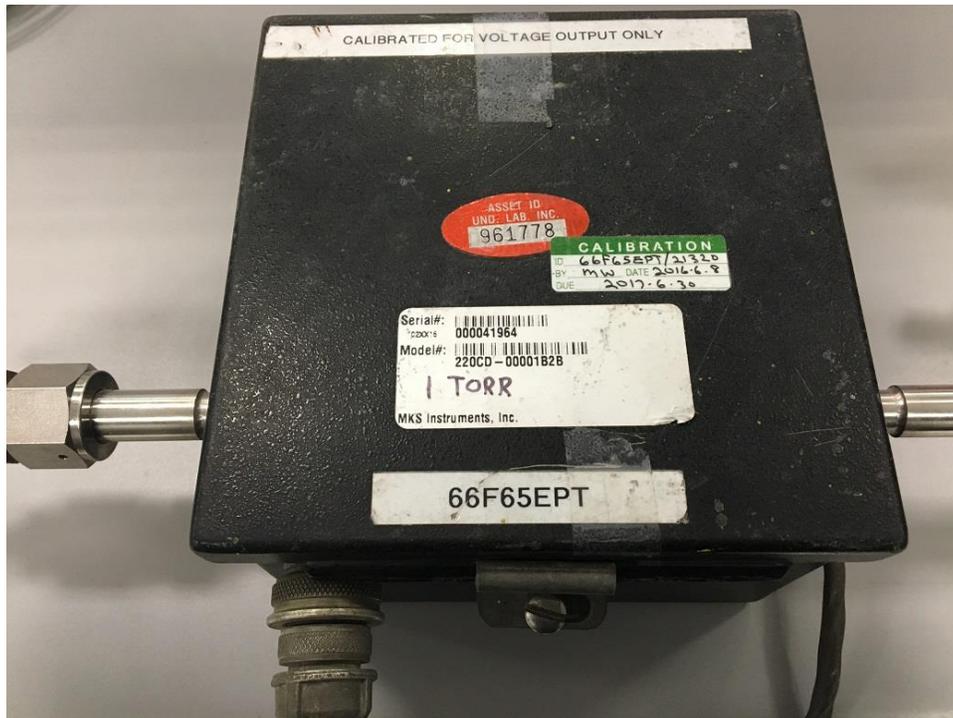
Figure 163 - PT\220DD 1 Torr

The 1 Torr pressure transducer monitored the pressure difference between the ISO room and the recovery box.

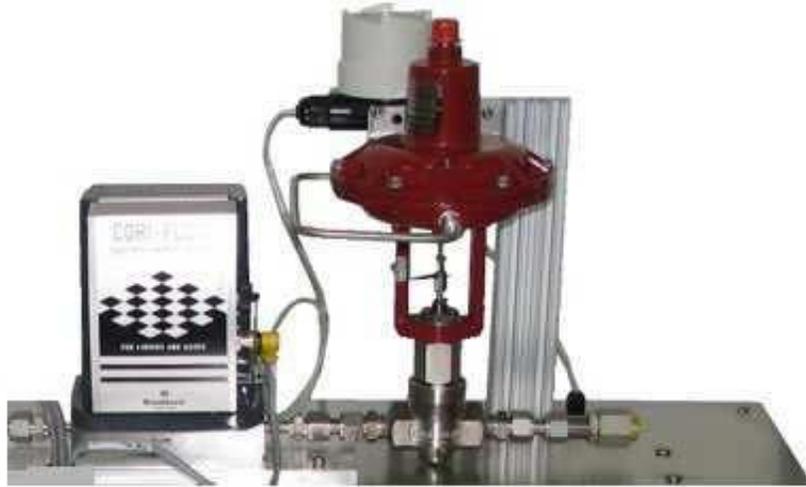
**Figure 164 - Other\Mass Flow Control System**

The mass flow control system was used to control and record the flow of refrigerant.

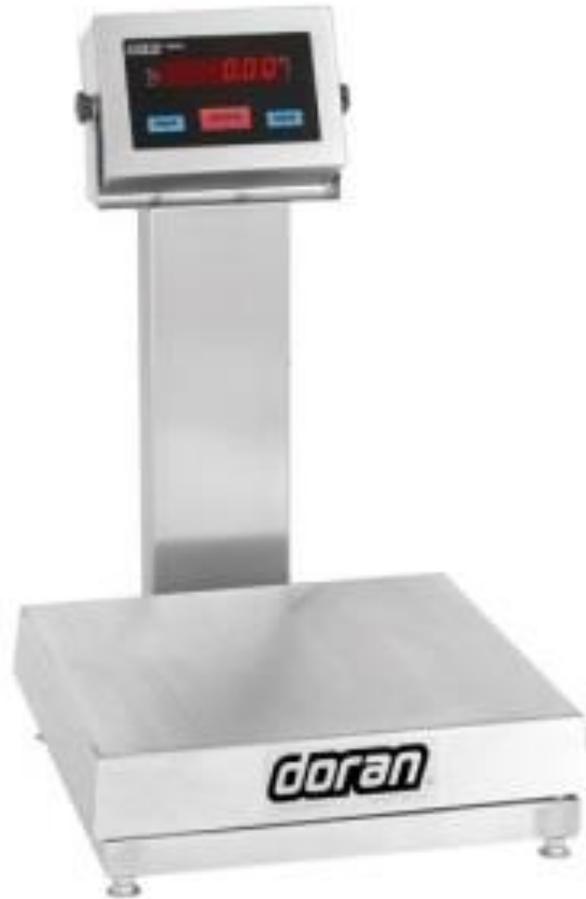
Figure 165 - SCL\7000xl

The 7000xl scale was used to record release and pressurizer tank weights before and after filling and also after release weight.

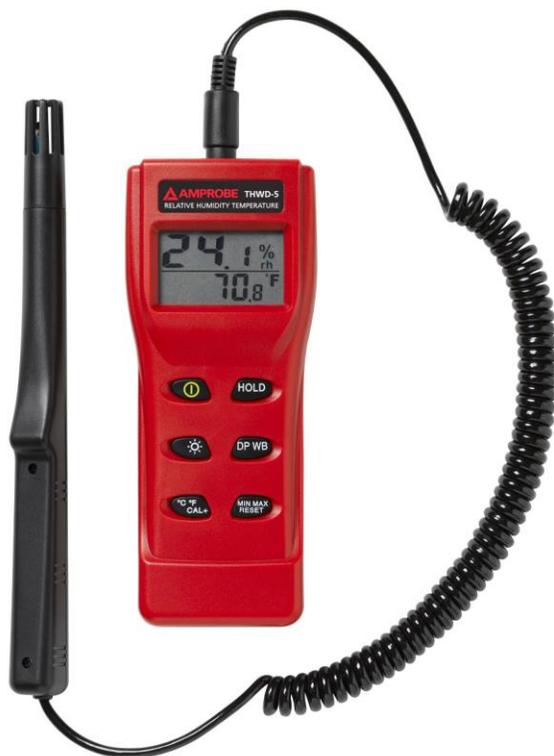
Figure 166 - THI\THWD-5

Handheld temperature humidity probe used to determine humidity at the beginning of each test.

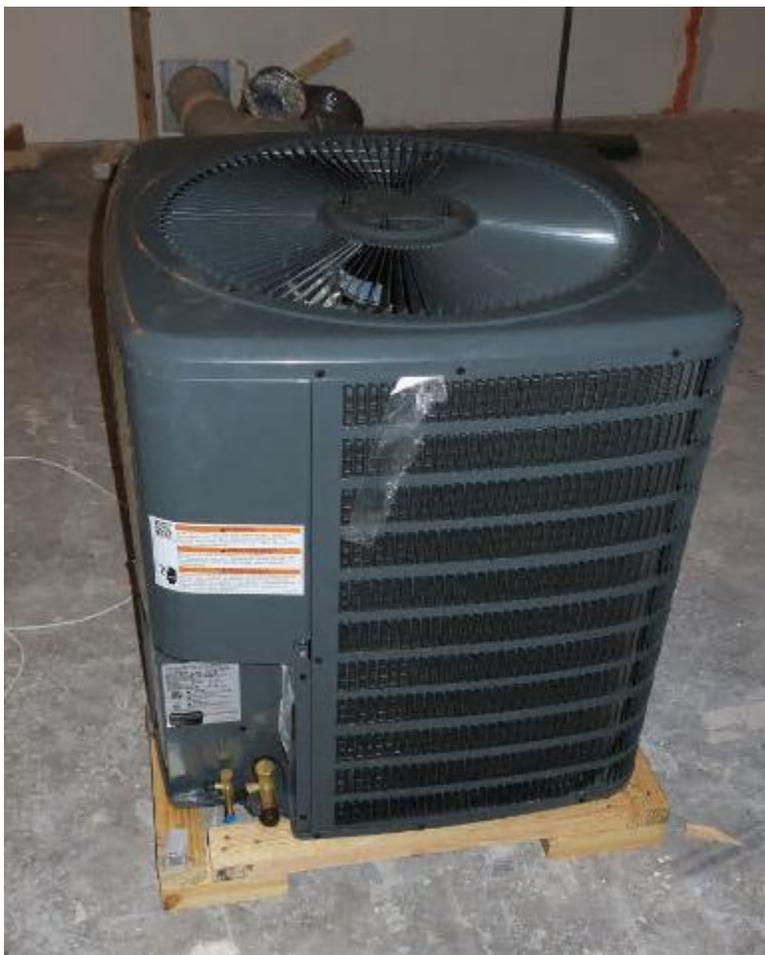
**Figure 170 – Outdoor Condenser and Compressor (Hermetic Electrical Pass-Through Terminal Failure Tests)**

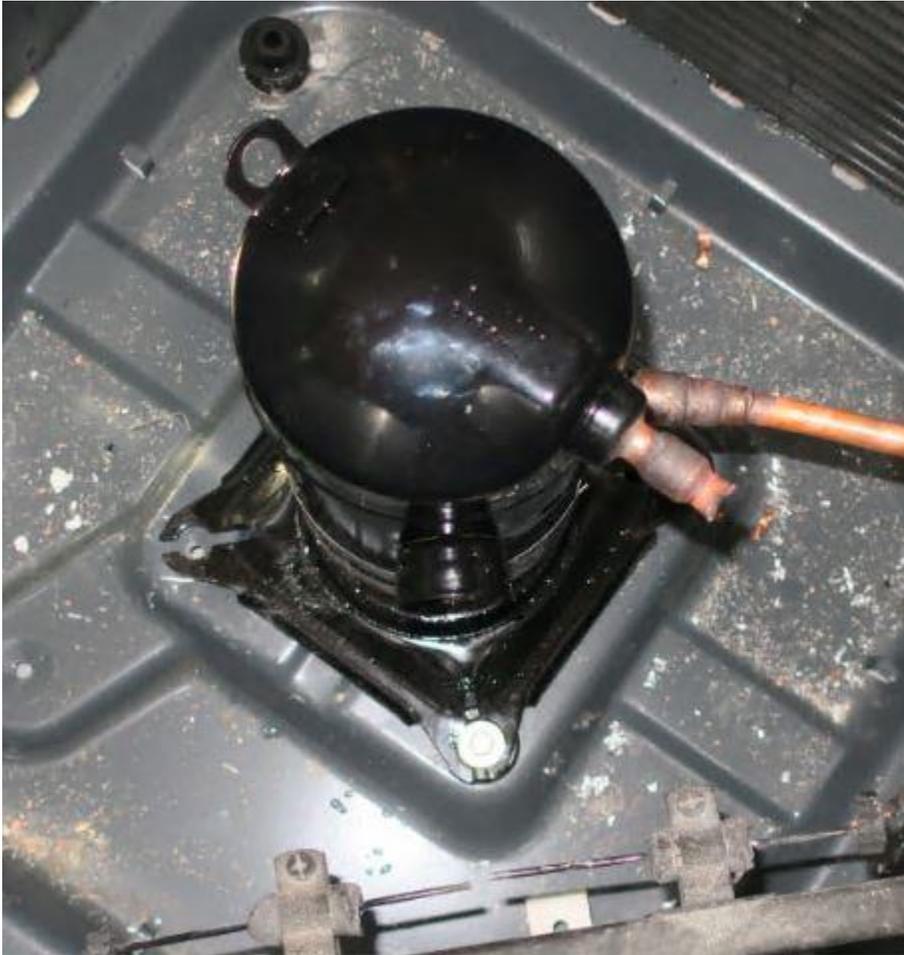
Figure 171 – Outdoor Compressor (Hermetic Electrical Pass-Through Terminal Failure Tests)

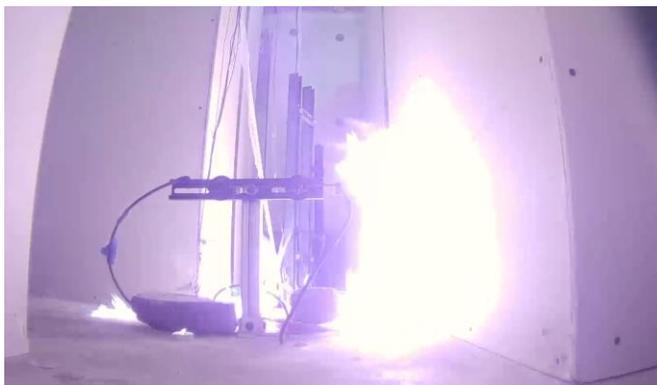
Floor level view at 46 seconds after the start of the discharge. Location C is in the foreground. At 57 seconds the flames reached the ceiling level. Flaming lasted for a total of 87 seconds.

The pressurizer was not used in this experiment. The release tank pressure dropped to near atmospheric within 120 seconds of the start of the discharge. Only 3.5 kg of the planned 5.2 kg discharge was completed. Selected data from this test are shown in Figure 175.

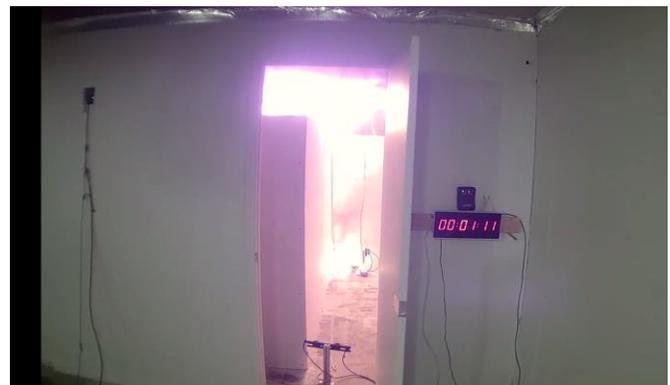
Figure 175 – Data from WALKIN02

The latch on the door was disabled in order to use the door as a deflagration vent. The door was forced open at 59 seconds after the start of the discharge.

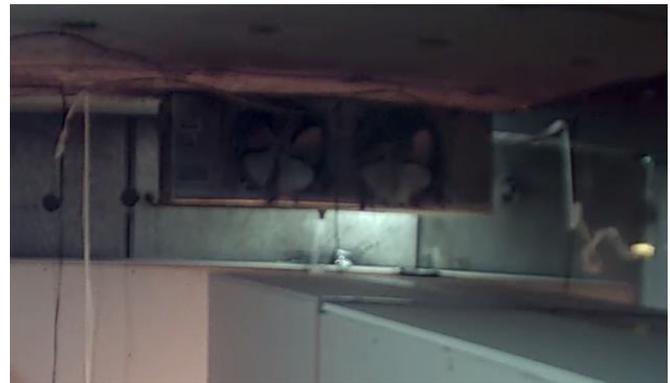
It appears that liquid refrigerant is dripping from the drain at 63 seconds after the start of the discharge.

Both the pressurizer and release tanks were used in this experiment. Selected data from this test are shown in Figure 177.

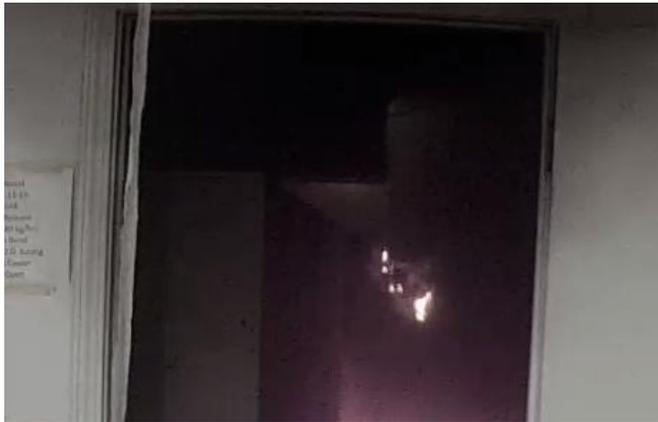
Up until 83 seconds, the fire was at the floor level. This frame shows embers from the cheesecloth floating up to the level of the unit cooler. This caused ignition at the ceiling level.

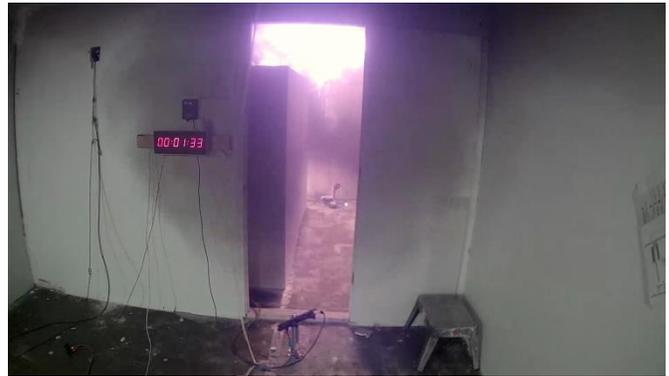
**Figure 177 – Data from WALKIN04**

At 85 seconds, the volume around the unit cooler was fully involved in flame and the peak pressure was recorded. This frame shows the peak pressure pushing a plume of smoke out of the walk-in cooler and toward the camera. The total duration of flaming was 58 seconds.

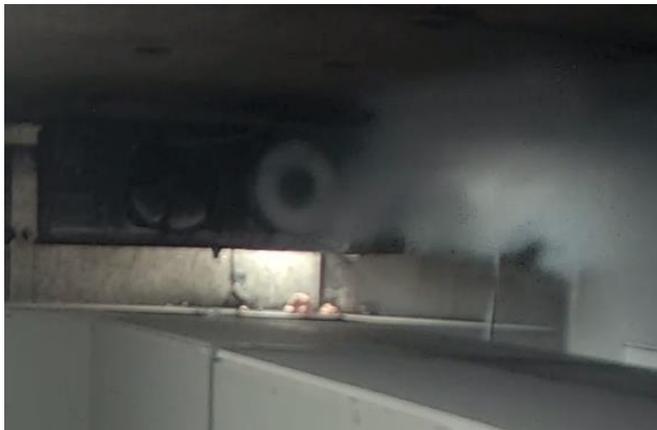
The discharge in the coil face caused the fan to rotate. Note the frost buildup on the right-hand fan blades.

The pressurizer was not used in this experiment. No ignition was observed. It was noted that the candles remained lighted, but were flickering due to the increased air circulation during the discharge. Selected data from this test are shown in Figure 178.

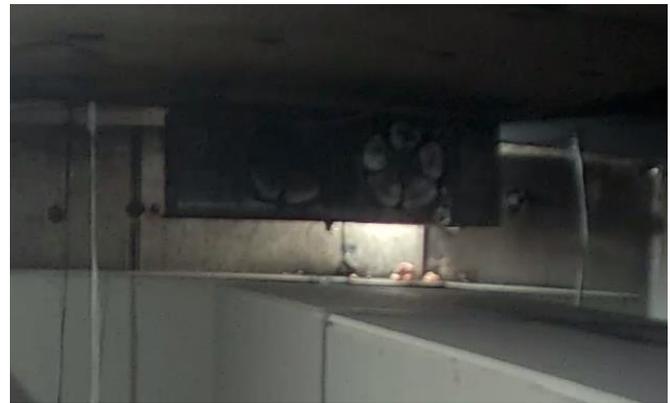
Figure 178 – Data from WALKIN05

After the discharge was completed the fan stopped rotation and the frost began to melt away.

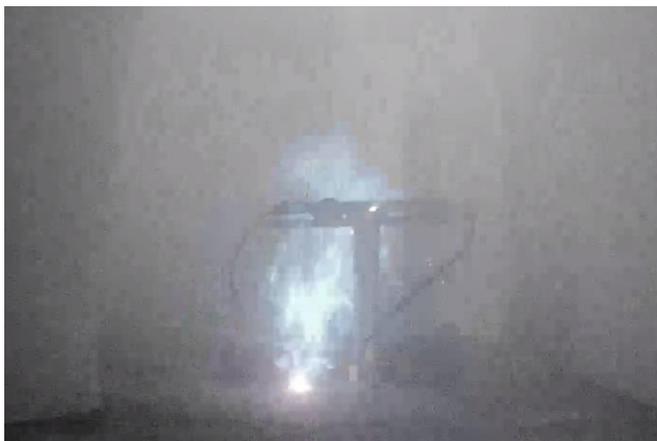
Sustained Ignition at floor level 59 seconds after the start of the discharge. Blue flames were seen to ignite and extinguish for three seconds prior to this frame.

Both the pressurizer and release tanks were used in this experiment. Selected data from this test are shown in Figure 179.

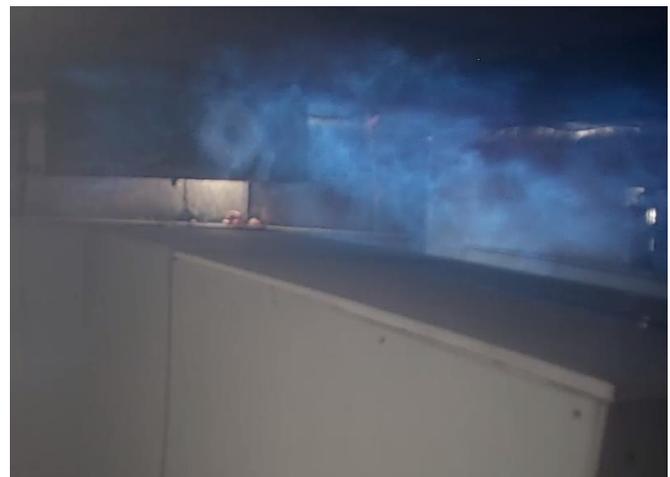
One second after the start of sustained ignition, the flames reached the ceiling of the walk-in. The total duration of sustained flaming was 9 seconds.

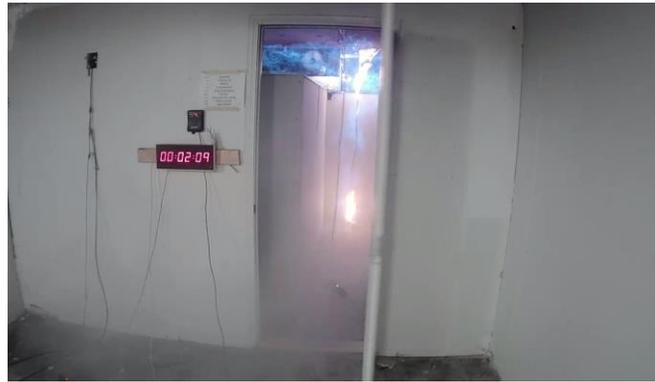
**Figure 179 – Data from WALKIN06**

At 61 seconds after the start of discharge, the walk-in door was forced open due to pressure from the ignition.

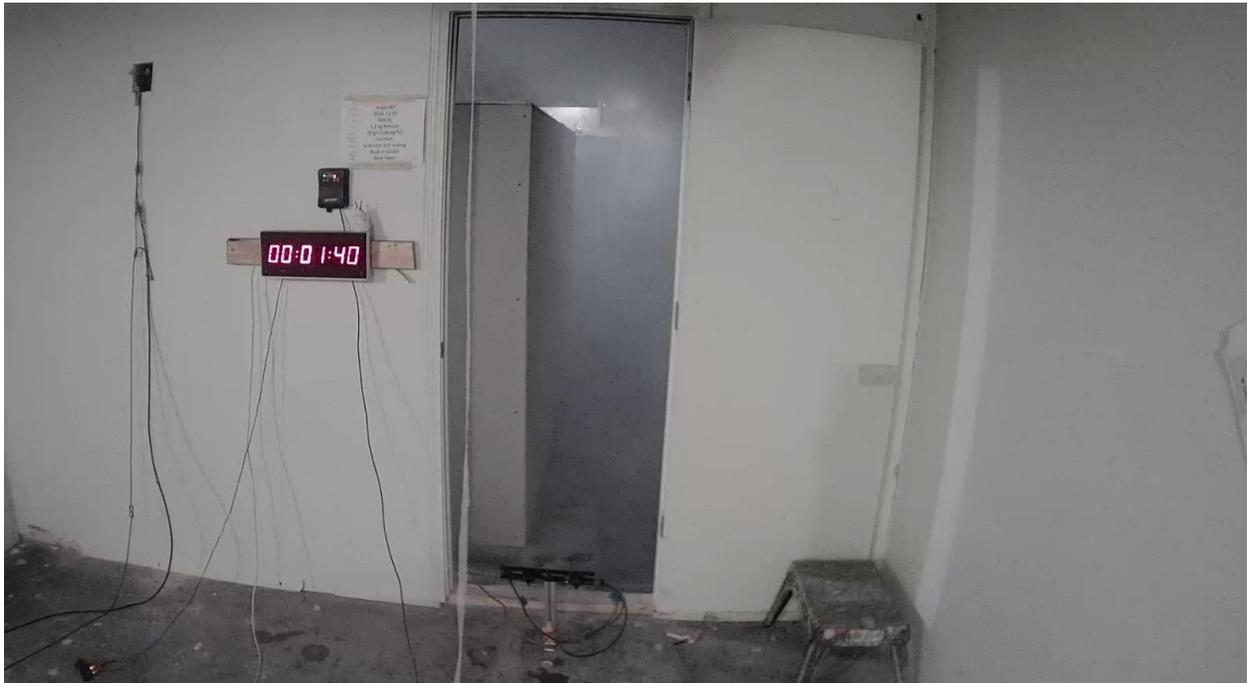
**Figure 180 – Data from WALKIN07**

There was no ignition during this test. The candles at all locations flickered due to both wind and the presence of refrigerant. Candles at location A, B, and C remained lighted throughout the test. The candle at location D (shown here) was extinguished at 92 seconds after the start of discharge and 27 seconds before the end of the discharge.

Both the pressurizer and release tanks were used in this experiment. Selected data from this test are shown in Figure 180.
